Motorized Trails Assessment Study

For Table 2
Trails
in the
Plumas
National Forest

Feather River
Ranger
District

Prepared by
Butte County
Resource Conservation District

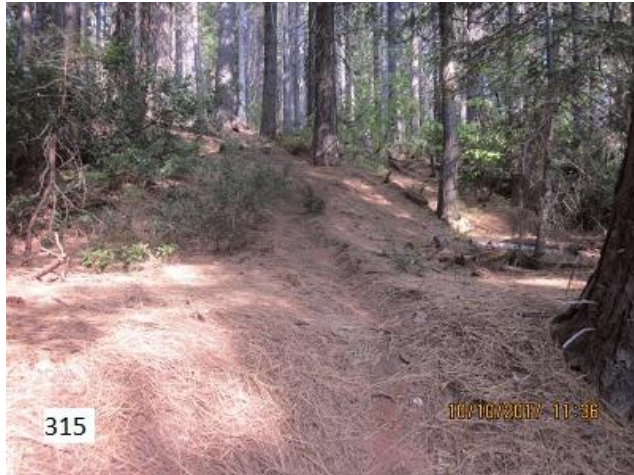
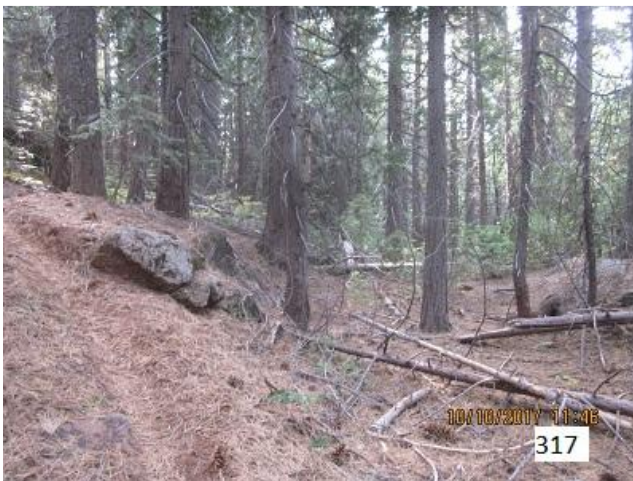
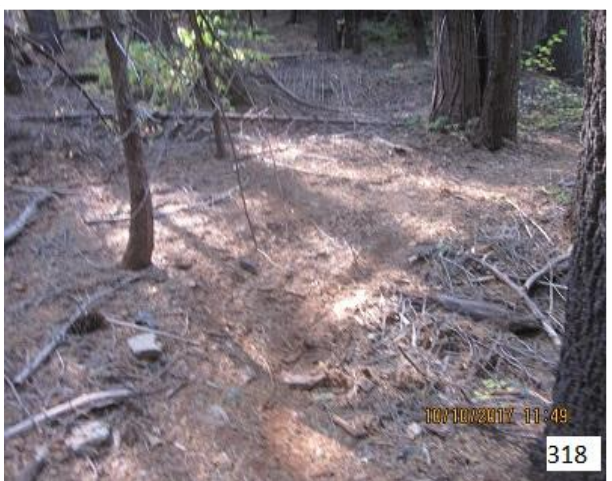
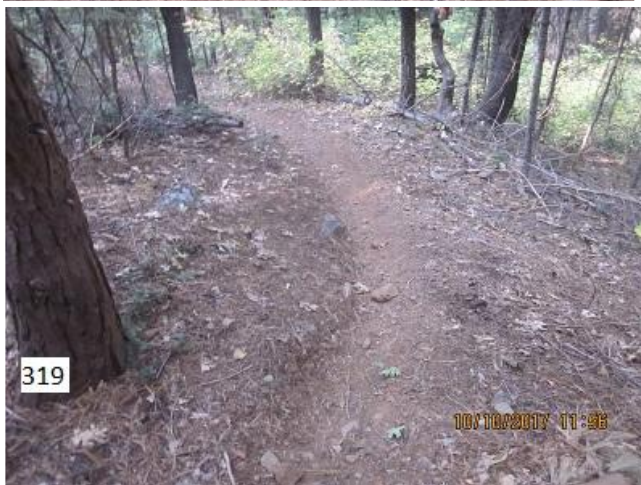
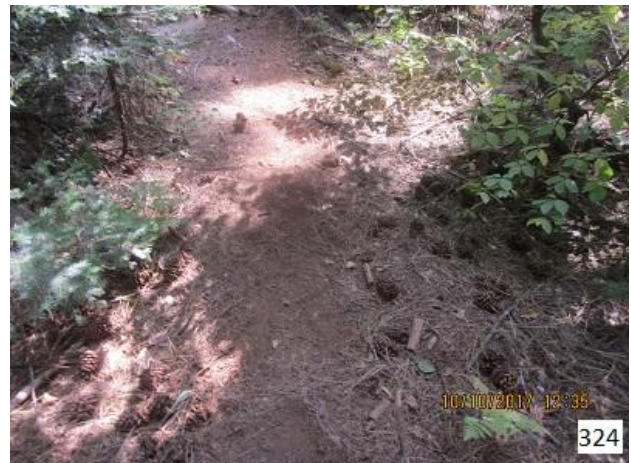
PHOTOS

Section Begin/End GPS Points	Section Length	Trail Slope	Crossings	Conditio n Code	Cause Code	Comments	Photo Numbers
B= 250	90 ft	20+%	N/A	Yellow	C7, C15	Trail shows medium usage, trail incision at entrance	313
E=251	330 ft	5%				consider reroute to lower grade	
B= 251	1260 ft	-5%	N/A	Green	N/A	trail meanders uphill, no sign of surface erosion	314
E=252						crosses small meadow area	
B=252	168 ft	-15%	N/A	Red	C7, C8	9-10 inch incision, no drainage, long run, consider reroute	315
E=253	324 ft	-25%	N/A			Grade to steep for effective RGD, trail connects to old road	
B=254	182 ft	0%	N/A	Green		Clear trees on old road, alternate created due to trees	316/317
E=255							
B=255	125 ft	0%	swell	Yellow	C19	armor swell (257) rock on site, unstable tread in swell	318
E=256							
B=257	255 ft	0%				trail drops off old road DH, -25% (258)	319
E=258		-25%				side-hill available to consider reroute	
B=258	290 ft	-25%		Red	C7, C8,C15

It is recommended that several reroutes should be created on the north end of 5M13 to reduce the grade of several sections and create a loop option to disconnect the over-grade portions of the trail. Once a reroute is complete to create a loop, the south end of the trail should be closed and restored.

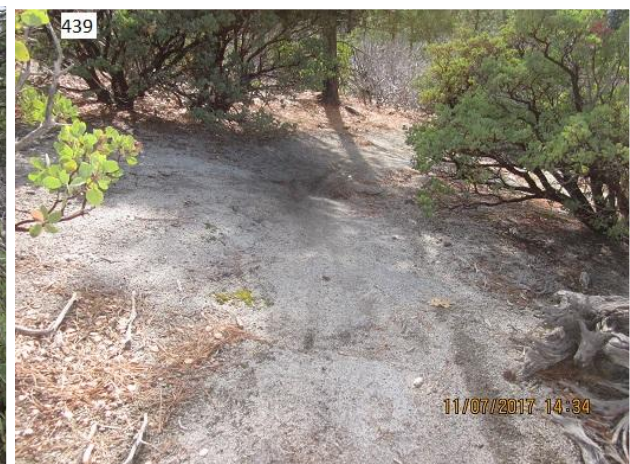
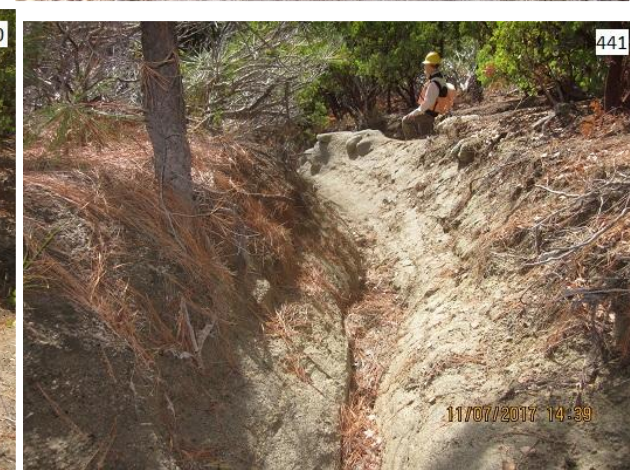
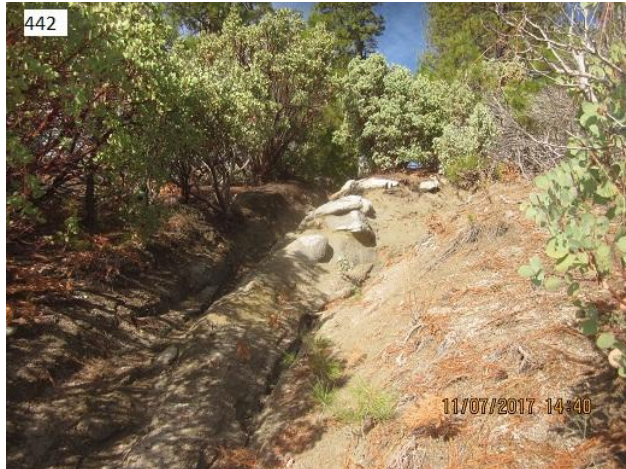
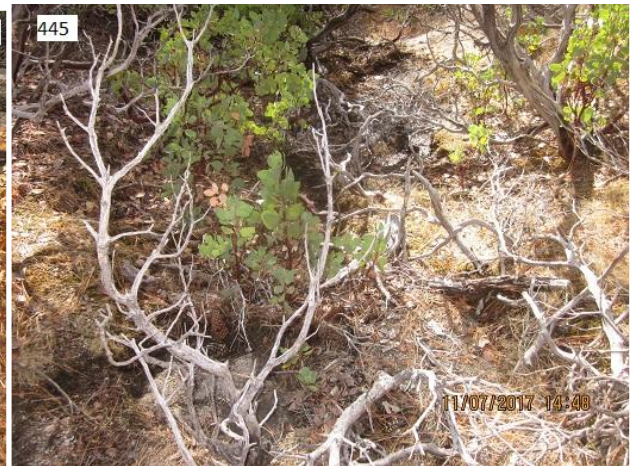
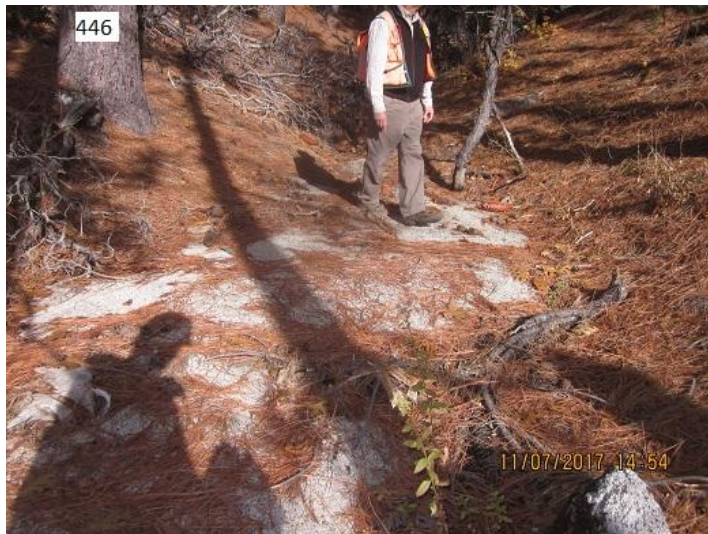
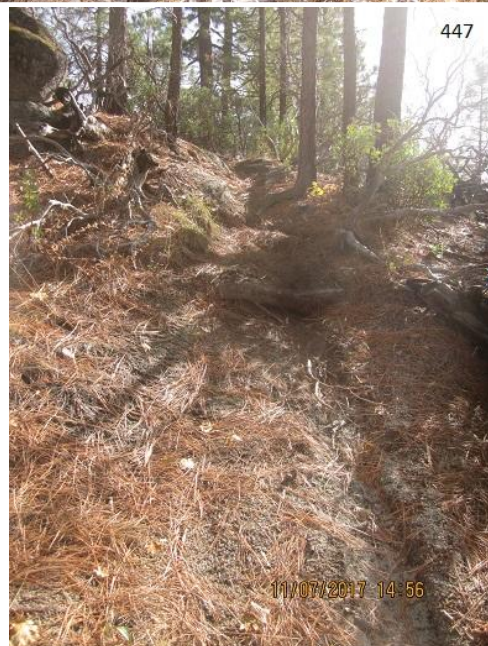
PHOTOS

Section B= Begin/ E=							Photo Numbers
End/ P=Point	Section Length	Trail Slope	Crossings	Condition Code	Cause Code	Comments	
B=363	160 ft	0%	n/a	Green		trail starts at road SM25	436
E=362	300 ft	-10%				minimal evidence of use at entrance off road	437
B=363	255 ft	-36%		Red	C7,C8,	3-3.5 ft incision, multi channel,	438/439/440/441
E=364						ephemeral stream at head, rare plants in area	
B=364		0	5%	Green		trail departs drainage	442
	244 ft					ephemeral crossing, no concern	443
	351 ft					swell	
	432 ft					ephemeral crossing, no concern	444
	500 ft	-20%				trail starts to descend ridge	
	575 ft	-10%					
	804 ft					trail descends into drainage	
E=365	863 ft	-28%				(365) crosses ephemeral drain from above	445
B=365	0 ft -55 ft	40%		Red- R2		sediment deposited into watercourse	446
	55 ft					climbs out of drain, heads DH	
	104 ft	-10%				swell- minimal scour	
	333 ft	-10%				trail on ridge between drainages	447

45 ft	10%				trail parallels stream/ not depositing levels at 45 ft	
	360 ft	25%				climbs	
	480 ft	10%				trail levels	
	642 ft					up/down	
E=369	700 ft					drainage divide (369)	
S=369	0 ft	-27%		Yellow		DH	
	65 ft	-5%				Levels	
	300 ft	-20%				DH	
	366 ft					swell, no impact	
	400 ft	5%				levels	
	460 ft	21%				climbs	
	500 ft					ephemeral crossing, not significant	
	600 ft	-5%					
	890 ft					ephemeral crossing, no issues	459
	960 ft	5%				ephemeral crossing, no issues	460
	1240 ft	27%				climbs	
E=370	1480 ft					drainage divide (370) heads DH	
B=370	0 ft	-22%				DH from drainage divide	
	130 ft					trail levels	
	213 ft	-12%				goes DH	
	382 ft					ephemeral crossing, no issues	461
	525 ft	5%				UH/DH	
	656 ft	21%				UP no incision	
	780 ft					trail sign- no official	462
E=371	990 ft						463

perennial stream crossing, would make a big impact to reduce hydro connectivity. In addition, tread maintenance should be completed end-to-end to help reduce natural resource impacts and allow for trail sustainability. Alternatively, the north end of the trail could be moved up hill to create a more contouring alignment and avoid going down the ridge. This layout would connect to the perennial stream higher in the watershed, which could create a better opportunity for a crossing and reduce erosion impacts.

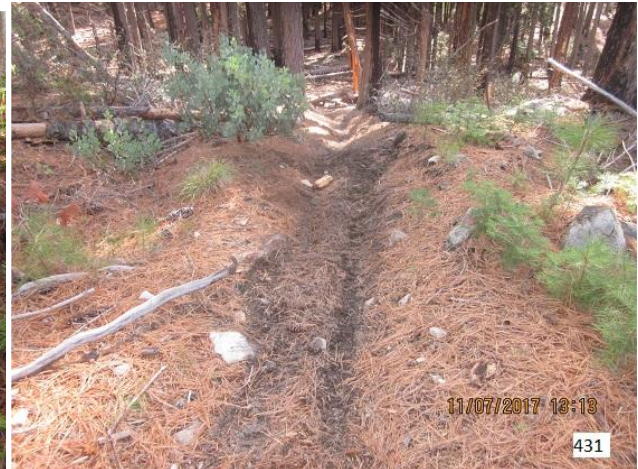
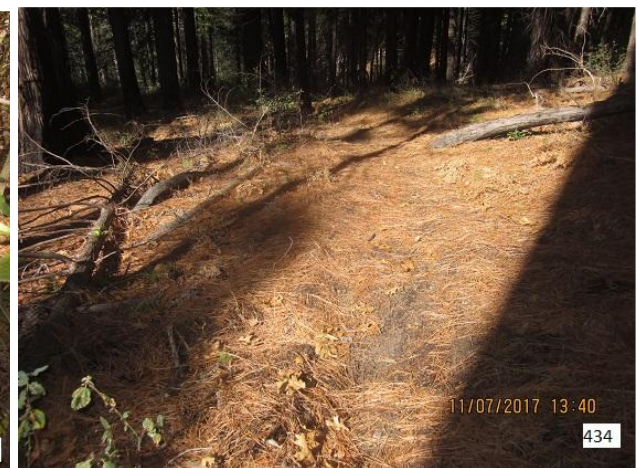
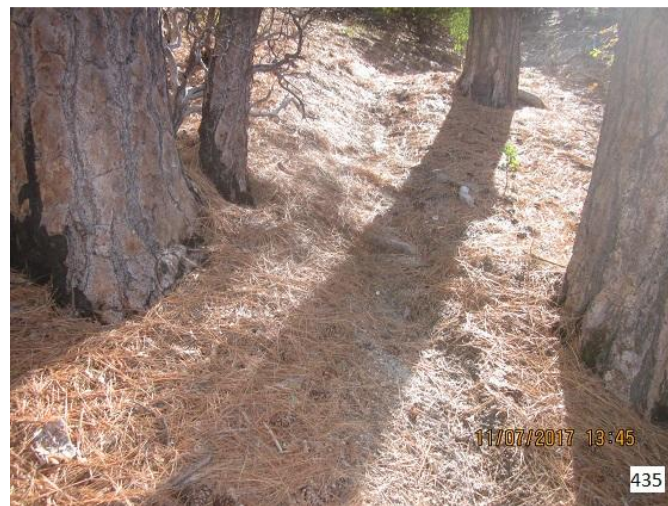
Damage to botanical species of concerns and soil erosion is occurring.

End/ P=Point	Section Length	Trail Slope	Crossings	Condition Code	Cause Code	Comments	Photo Numbers
S=349	75 ft	-18%		Yellow		trail starts, evidence of moderate use	418
	139 ft	10%				at 70 ft trail enters from R (350) minimal use	419
	275 ft	-6%				DH/UH, no incision	
	360 ft	5%				DH/UH, no incision	
	510 ft	21%				low area, reroute to hill side	
E=351						steep UH, reroute to side slope	
S=351	160 ft	-23%				reroute to side hill,	
	430 ft	27%				incision 2'	420
E=352	0 ft	-20%				rock outcrop at top of steep grade	421
S=352	315 ft	-35%				leaves ridge, DH on DG ridge	422
	560 ft	-25%				saddle at 315 feet- SOC in area	423
	644 ft	-13%				saddle goes DH- SOC in area	424/425
E=353	833 ft	-10%				departs ridge DH	
B=353	180 ft	-16%				ephemeral crossing, steep grade in/out	426
E=354						scour, sediment dam created by trail	
B=354	80 ft	38%				incision 2-2.5'	
E=355	250 ft	24%				ephemeral crossing, durable/ limited scour	427

Much of the damage to botanical species of concern and erosion issues are on the same ridge line. Creating a reroute to remove the fall line section of trail will allow for protection of species and reduce the erosion impacts.

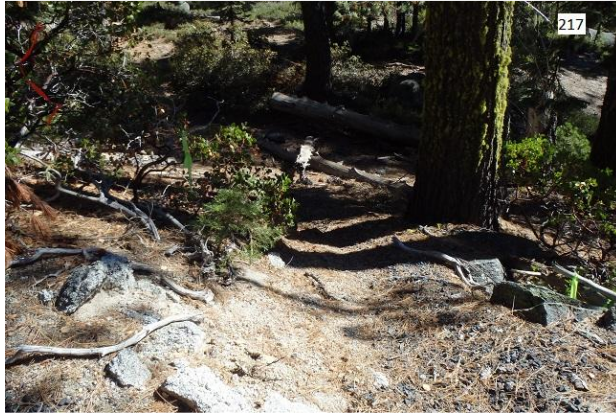
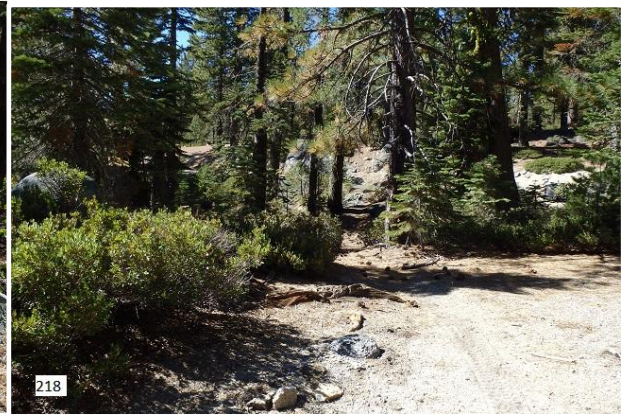
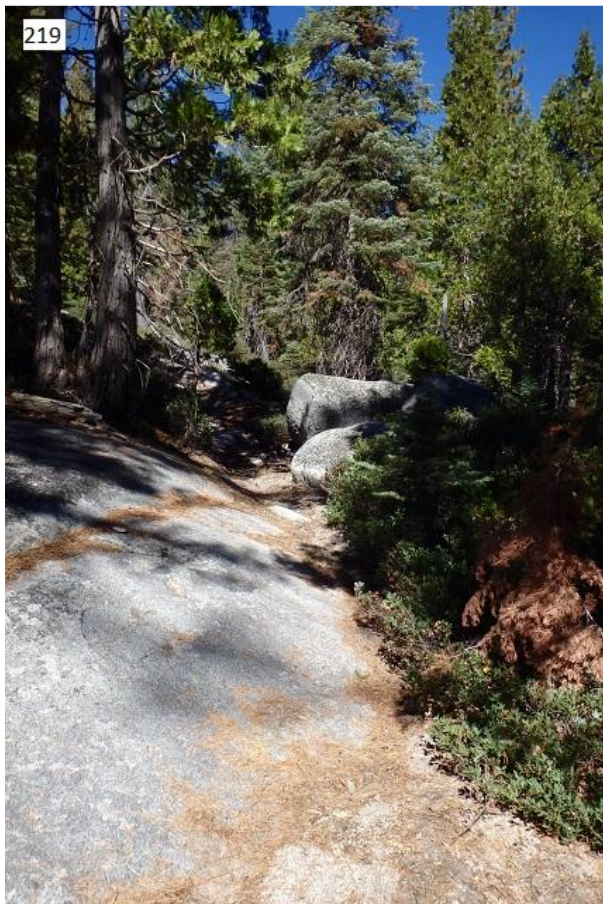
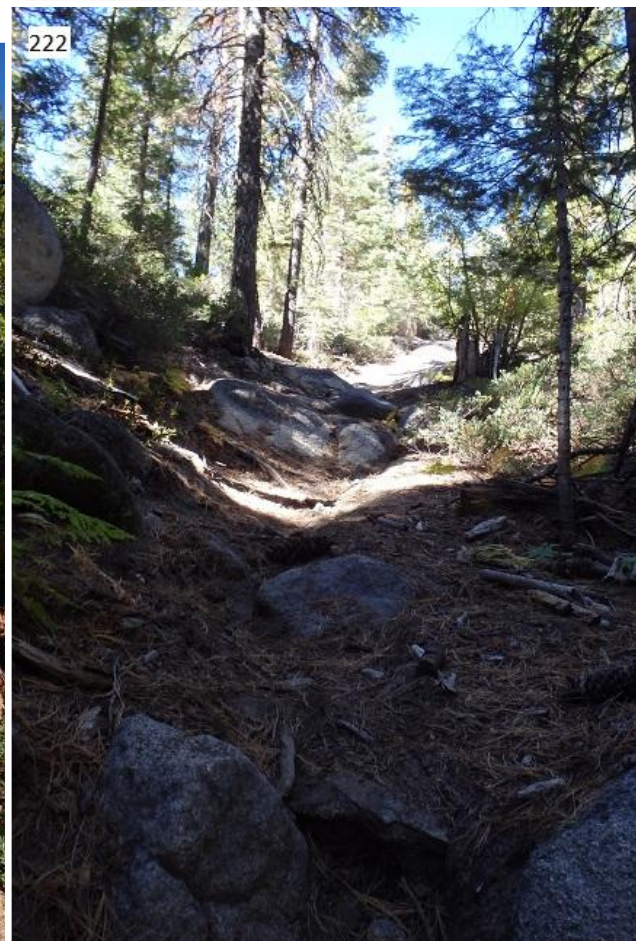
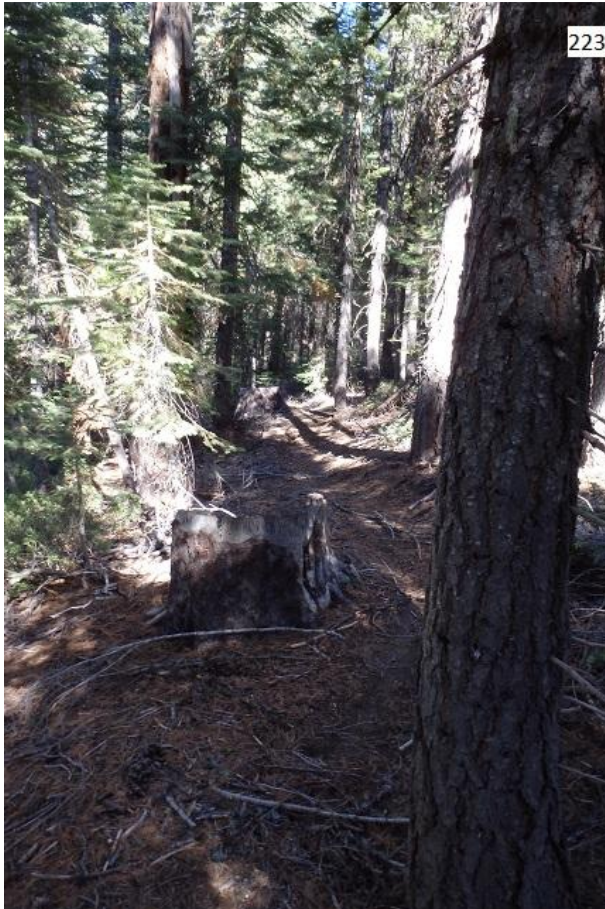
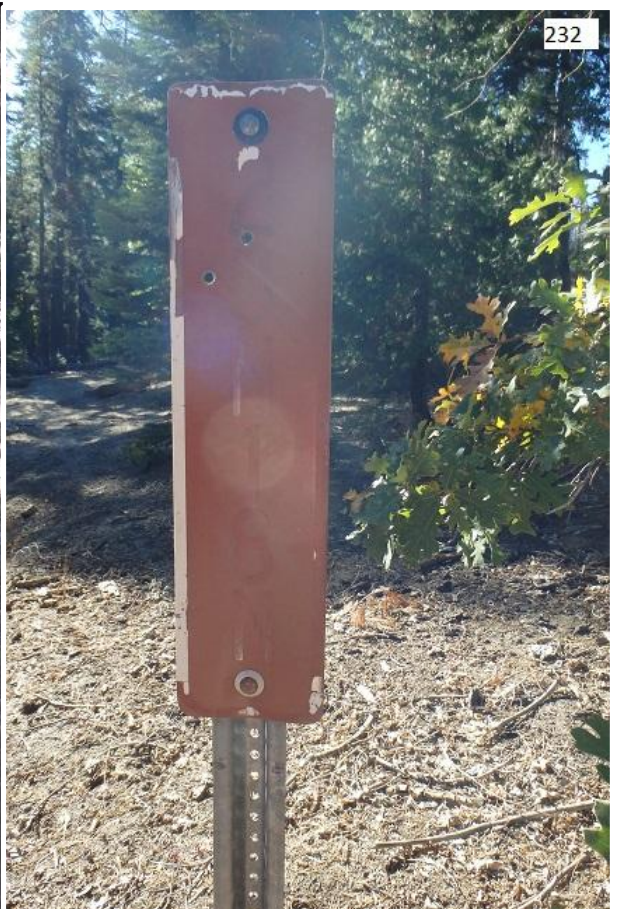
PHOTOS

End/ P=Point	Section Length	Trail Slope	Crossings	Cause Code	Comments	Photo Numbers
B=644	100 ft	-8/ -15%			trail start, shows evidence of use,	217
E=645					trail dips and climbs, NC	218
B=645	133 ft	-15/ -20%			NC, trenching, soil loss, DG, filtration at flat spot	219
E=646					P=646 short flat spot	
B=646	153 ft	-30/ -35%			trail goes fall line, entrenched DG, intermittent stream at bottom	222
E=647						
P=647					Site 11 intermittent stream, stagnant step pool, no surface flow, riparian veg (alder) higher grade, soils in stream from trail V shape BFF=5 ft, TP 20wx4d, consider reroute	LB 220 RB221
B=647	390 ft	+5/ +25 %			Trail climbs to ridge, install 5 RGD, NC	223
E= 648						
B=648	640 ft				trail drops and goes flat, NC	
E= 649						
P= 649					Site 12 perennial stream, riparian veg (alder, ferns), road above DG deposited from culvert not trail, not much discharge, cut bank above utilize pavers to armor, look for possible re-route?, trail next to stream	224 225 226

P= 657					Site 14 intermittent stream, some sediment deposition from trail riparian veg (alder), developed channel, BFF 3 ft, 10wx3d, stable in channel not flowing, moist mud, armor crossing	233
B=657	380	+10/ +15%			NC, install 5 RGD	
E=658						
P=258					End of trail	234

Recommendations: Although 6M22A has a high level of resource impact this trail is a valuable part of the overall network. It is recommended to reroute almost all the current trail and completely disconnect the north end of the trail, which has a number of problem areas. The recommended reroute avoids all stream crossing and fall line trail alignments. In addition, the reroute would take advantage of a great view shed to the west of the current trail, and include technical rock elements. The overall distance of the reroute would be similar to the current alignment.

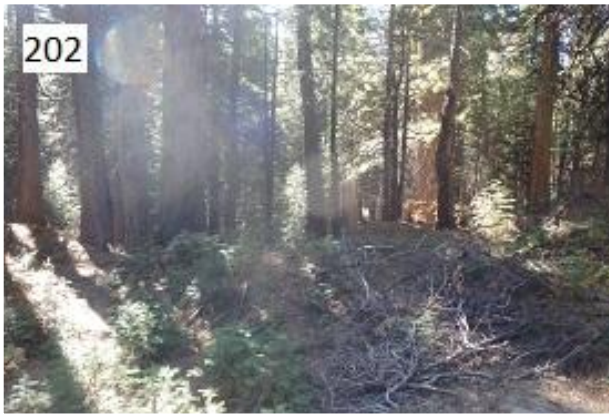
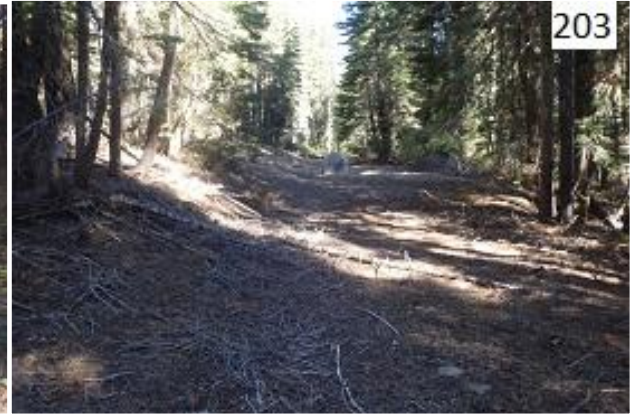
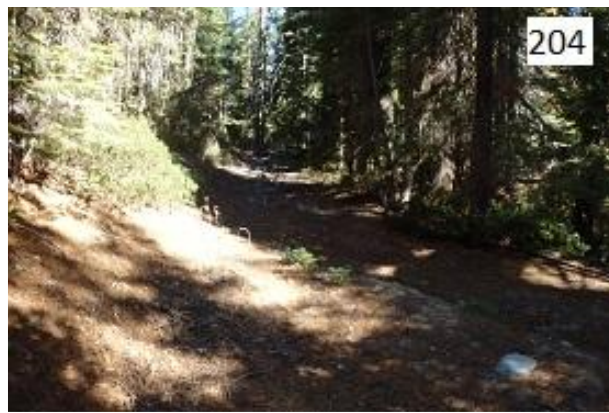
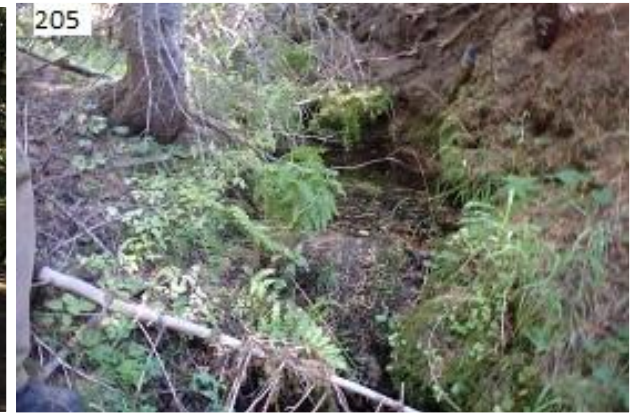
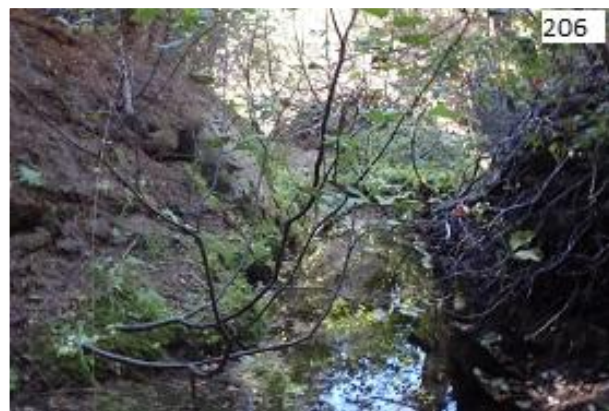
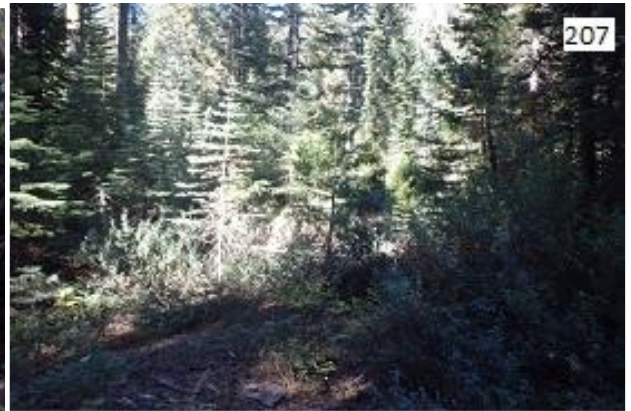
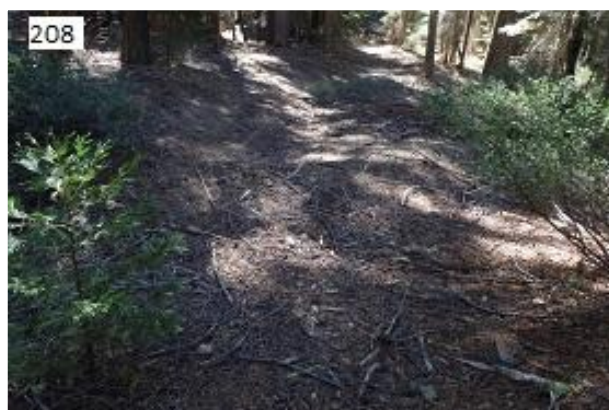
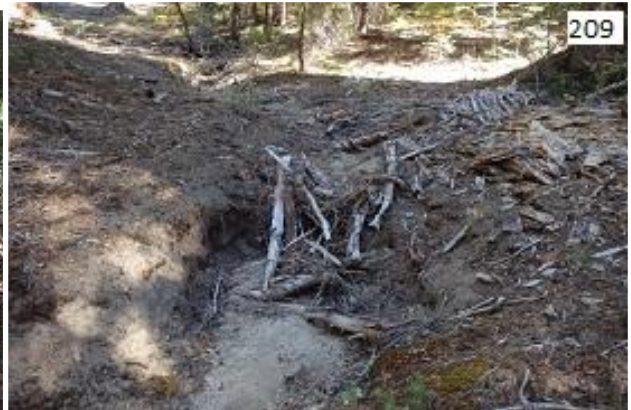
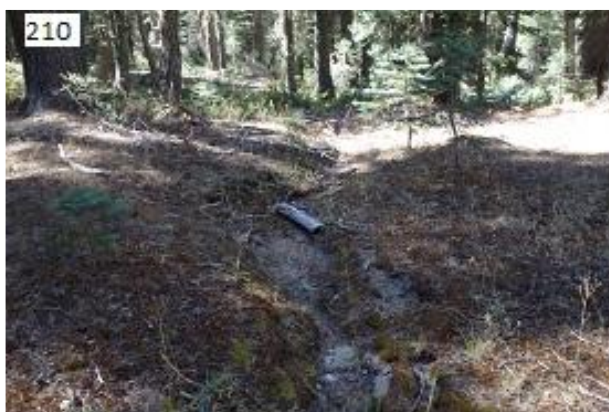
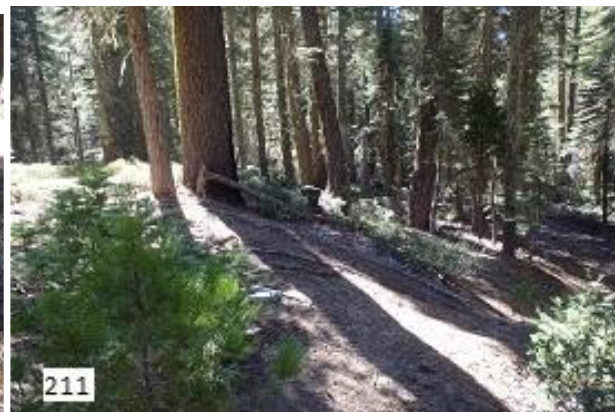
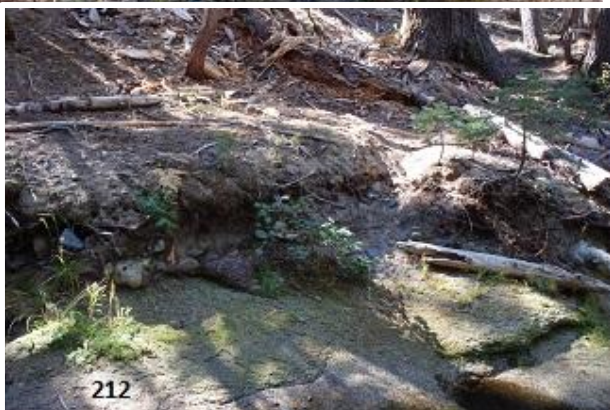
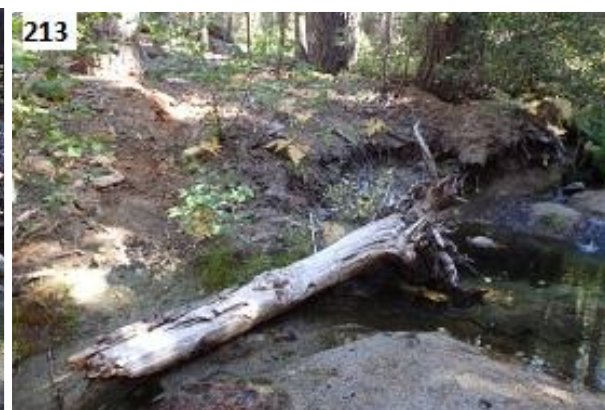
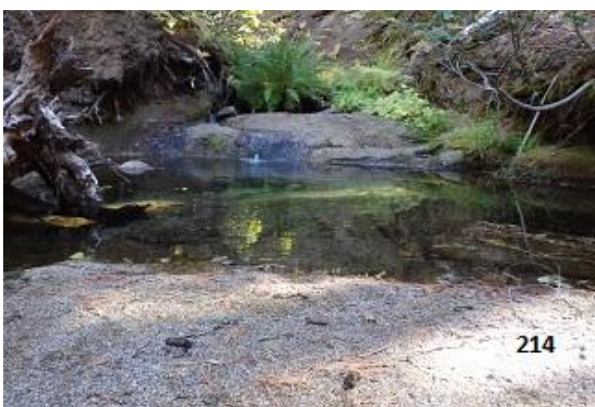
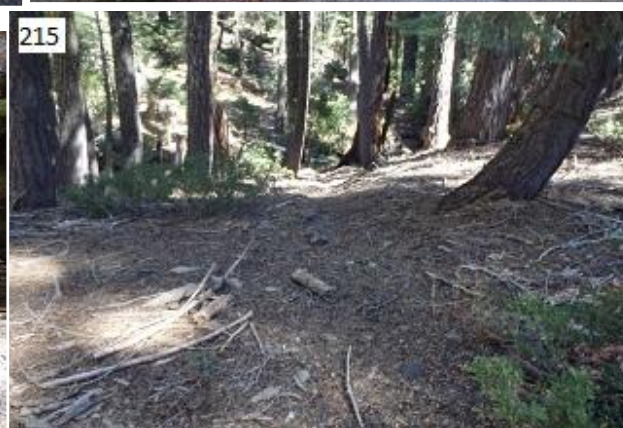
PHOTOS

End/ P=Point	Section Length	Trail Slope	Crossings	Condition Code	Cause Code	Comments	Photo Numbers
B=628	900	-5%				no evidence of use, 20-25' wide	
E=629		-12%				water bars in place, no sediment loss	202
B=629	134 ft	0%				flattens out, old landing, trees in trail	
E=630		3%				(630) end of landing	
B=630	575 ft	0%				trail stays on ridge top, flat/ wide	203
E=631		-5%				WB's intact no NC, leaves map trail	
B=631	455 ft	-10%				flattens out and heads DH, wide	
E=632		-20%				stays on ridge, WB's functioning	204
B=632	200 ft	-5%				old landing	
E=633		-8%					
B=633	340 ft	-10%				highly entrenched, big boulder block trail	
E=634		-15%				WB's functioning	
B=634	Site					intermittent crossing, deep V 10"x15'	205/206
						surface/ subsurface flow, possible US crossing	
B=634	346 ft					overgrown, hard to follow, mostly flat	207
E=635							
B=635						Mine Site (636) shows evidence of use	208
E=637						trail intersection leading down to mine site

B=637		3%				overgrown side slope	
E=638		5%					
B=638	424 ft	-5%				trail forks, L-crosses ephemeral at 240 ft	
E=639		-12%				better trail crosses lower on stream	
639	Site	-10%				ephemeral stream, highly eroded	
						headcut at crossing 2.5', stays in channel	209 US
						150' draining down road, no water present	210 DS
S=639	650 FT	-3%				install 8 RGD, goes off map trail,	
E=640		-15%				contours above creek NC	
S=640	200 ft	-25%				goes fall line for 20 ft, splits R existing trail/	
E=641		2%				L mapped road, rejoins road	211
S=641	95 ft	-15%				goes fall line to creek	
F=642							
	642 Site					Perennial stream- tributary of Big Boulder Creek	212 R
						stays in channel, minned to bed rock, durable crossing	213 L
						unstable bank soils, sides sluffing (not due to trail)	214 US
						W 15'x15' 6", high gradient step pool	
S=642	110 ft	20%				goes UH to flat landing -mine site (643)	215
E=644		0%				Trail End- connects to 6M29

Due to low recreational value, redundant connectivity, and the high cost of bridge infrastructure, it is recommended that no investment be made in this trail and that it not be added back to the MVUM.

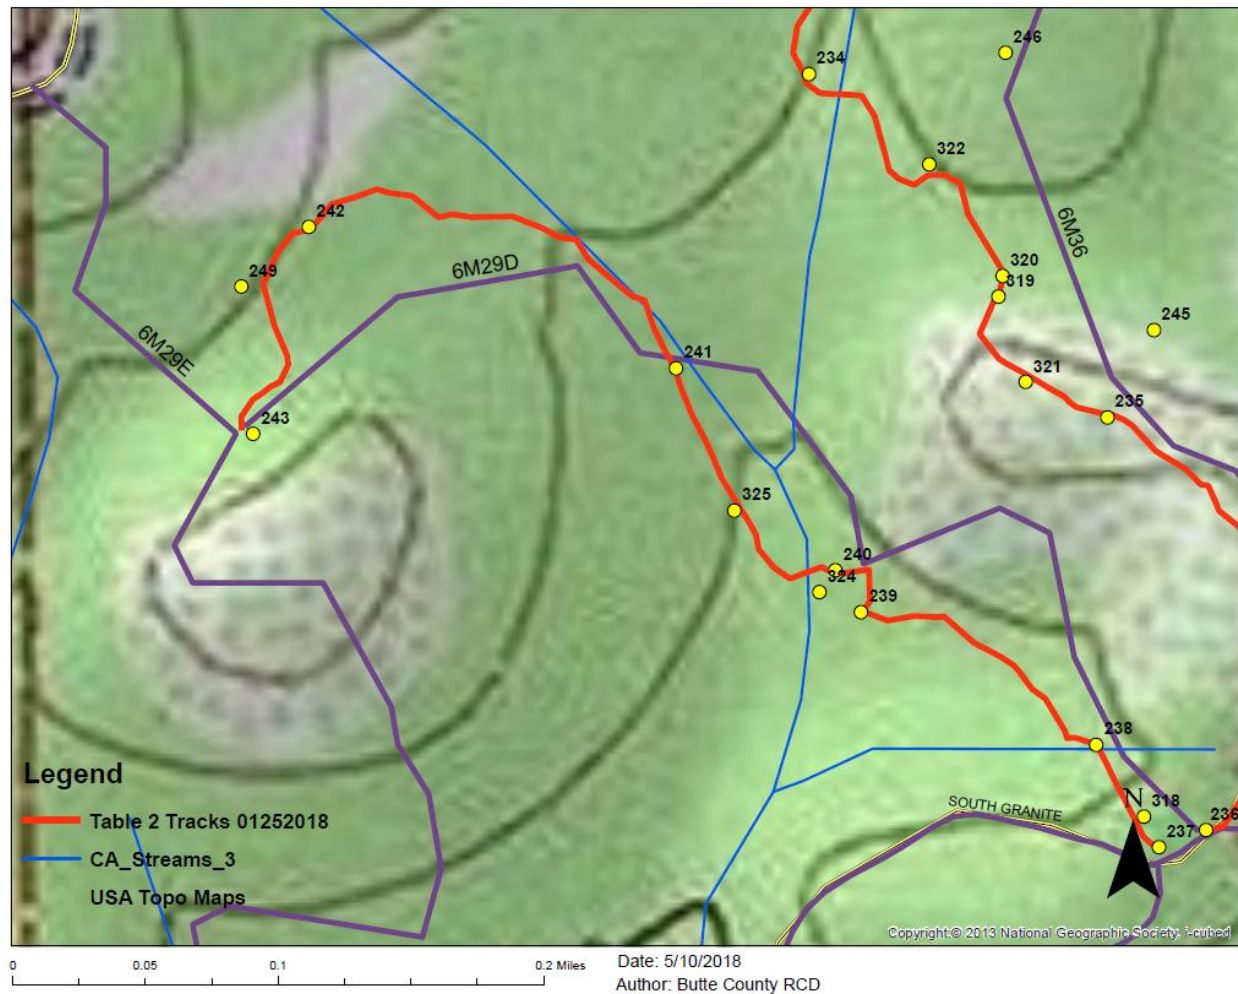
Table 2 Trails Survey -6M29D

Section B= Begin/ E= End/ P=Point	Section Length	Trail Slope	Crossings	Cause Code	Comments	Photo Numbers
B=237 E=238	240 ft	0%			starts slightly off map trail, rejoins flat, DG, trail used frequently, evidence of maintenance	306
B=238 E=239	500 ft				trail moves off map trail, goes next to ephemeral stream soil destabilization, HC possible, reroute up hill	307
B= 239 E= 240	160 ft				trail parallels stream and drops into perennial stream	
P= 240					Site 7 Perennial Stream, some cobble present, box shape, evidence of past mining stable in channel, minor sedimentation, slightly incised, riparian veg (alder, sedges, ferns) Consider armored crossing or bridge	308 LB 309 RB
B= 240 E= 241	1600 ft				ground trail departs map trail, install 8 RGD, P=241 connects back to map NC	
B=241 E= 242	840 ft	+5/ +20%			ephemeral on R not connected to trail, install 10 RGD, complete RGD maintenance, NC	
B= 242 E= 243	452 ft	+5/ +10%			RGD maintenance, install 5 RGD P=243 trail ends, connects with 6M29E	310

It is recommended that a bridge be installed across the stream, and drainage features be installed and maintained.

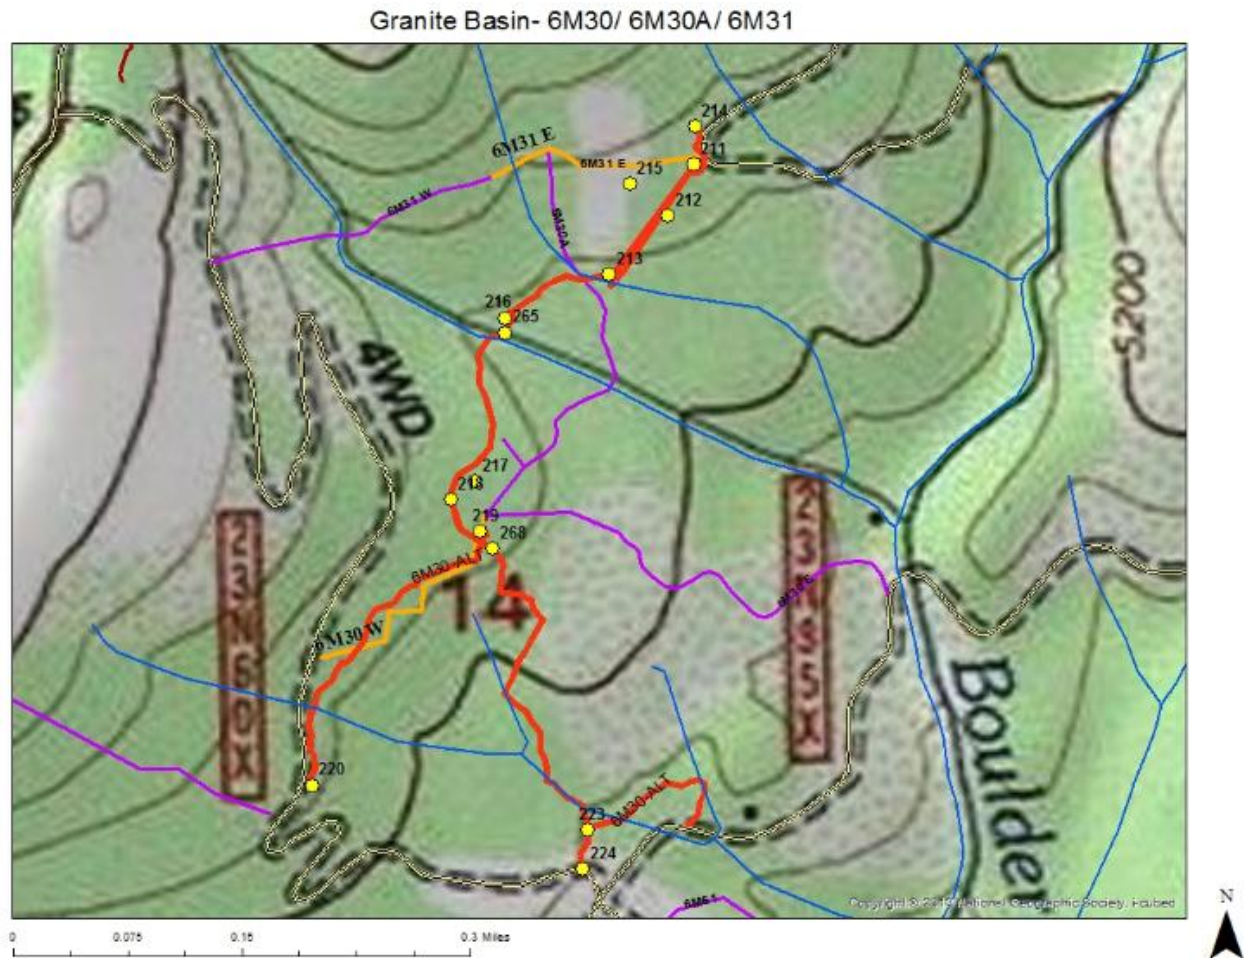
Trail	6M30						
Date	10/4/2017						
Vehicle Type	M						
Trail Difficulty	Difficult						
Location	Granite Basin						
Begin Segment	219						
End Segment	224						
Track ID							
Trail Distance	0.25						
Avg Trails Slope							
Survey Completed by	Thad/ Aric						
Section B= Begin/ E= End/ P=Point	Section Length	Trail Slope	Crossings	Condition Code	Cause Code	Comments	Photo Numbers
219	0.2	5%		Green		6M30 splits at intersections with 6M30A	
		20%		Yellow		Trail is incised	
223				Red		Perennial spring with bridge crossing	
224	0.05					Trail ends at road 23N60X	
Alternate							
223	0.2	8%				Reroute trail north of stream to avoid crossing connect into 23N23

Create a reroute that will disconnect the trail from the crossing bridge. Remove the bridge, then rehabilitate the area.

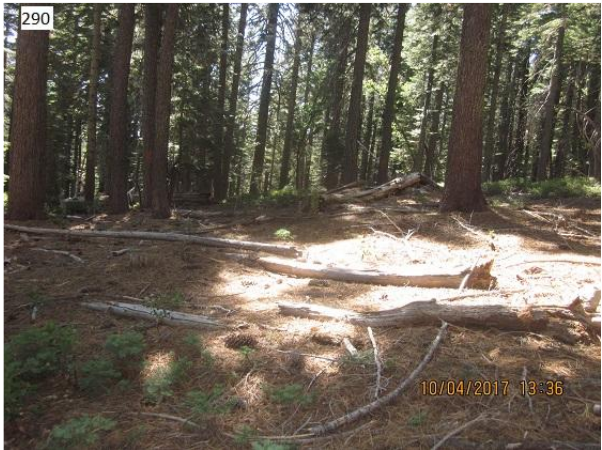
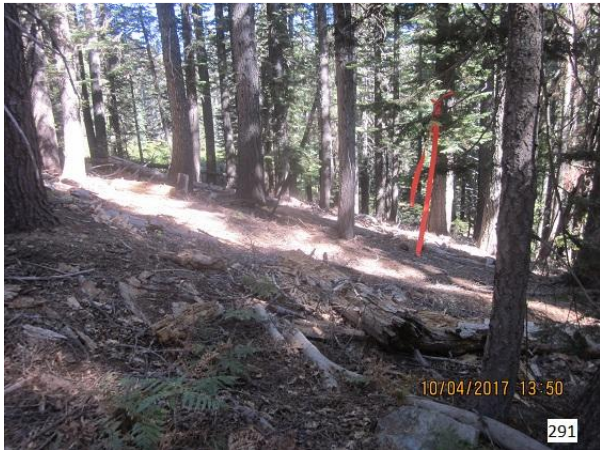
PHOTOS

Section B= Begin/ E= End/ P=Point	Section Length	Trail Slope	Crossings	Cause Code	Comments	Photo Numbers
B=219					no evidence of trail on ground	290
E=220						291
Reroute						
B=219		5%			Laid out new trail 5-8% grade	
E=220		8%			connects to 23N60X track: 2017-10-05 102113

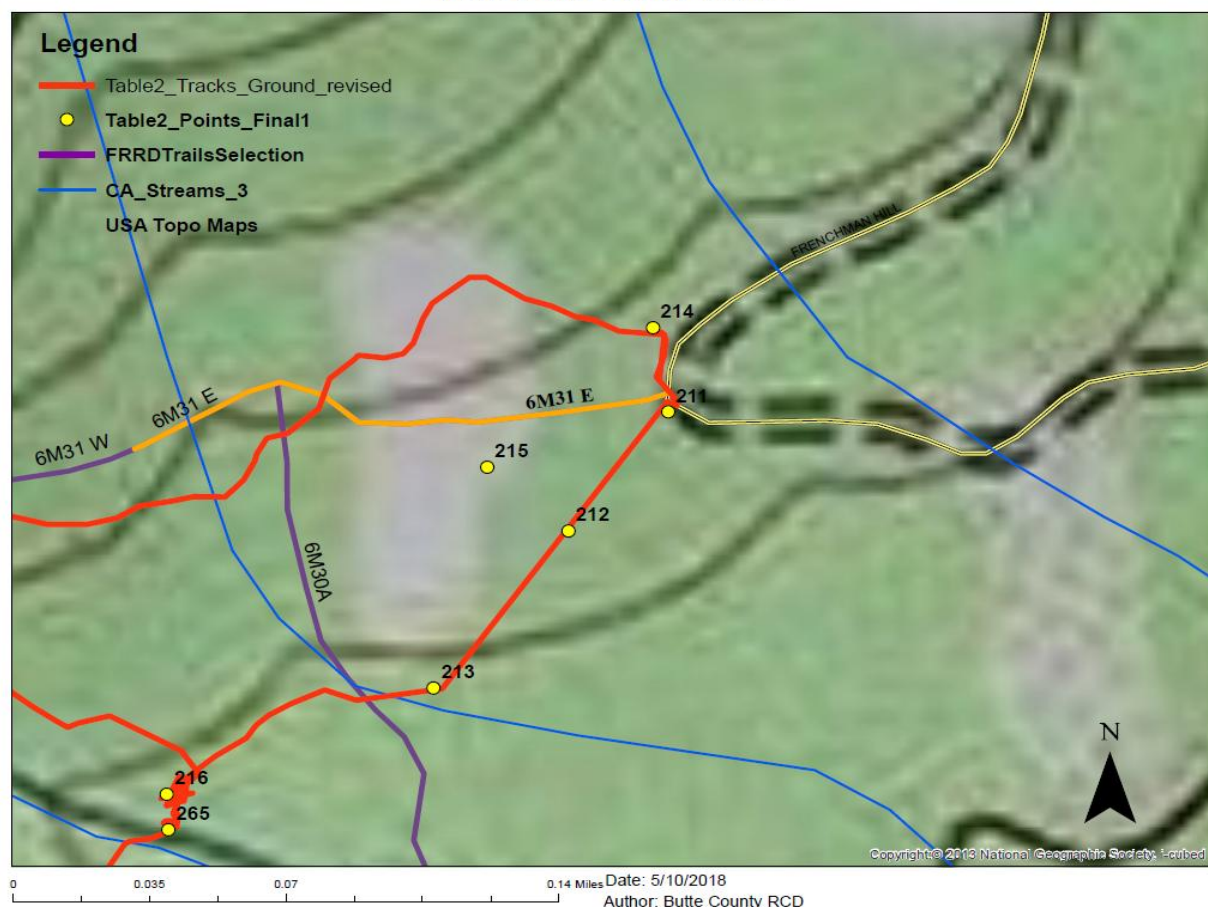
Table 2 Trails Survey -6M31E

Observations: Mapped location starts at road failure and goes into riparian area

End/ P=Point	Section Length	Trail Slope	Crossings	Cause Code	Comments	Photo Numbers
B=211					Trail starts at road failure in bend	283
E=215					no evidence of trail, goes into riparian area 6M30 trail on ground, continues	284

Recommendations: Trail is not on ground and should not be added back to MVUM.

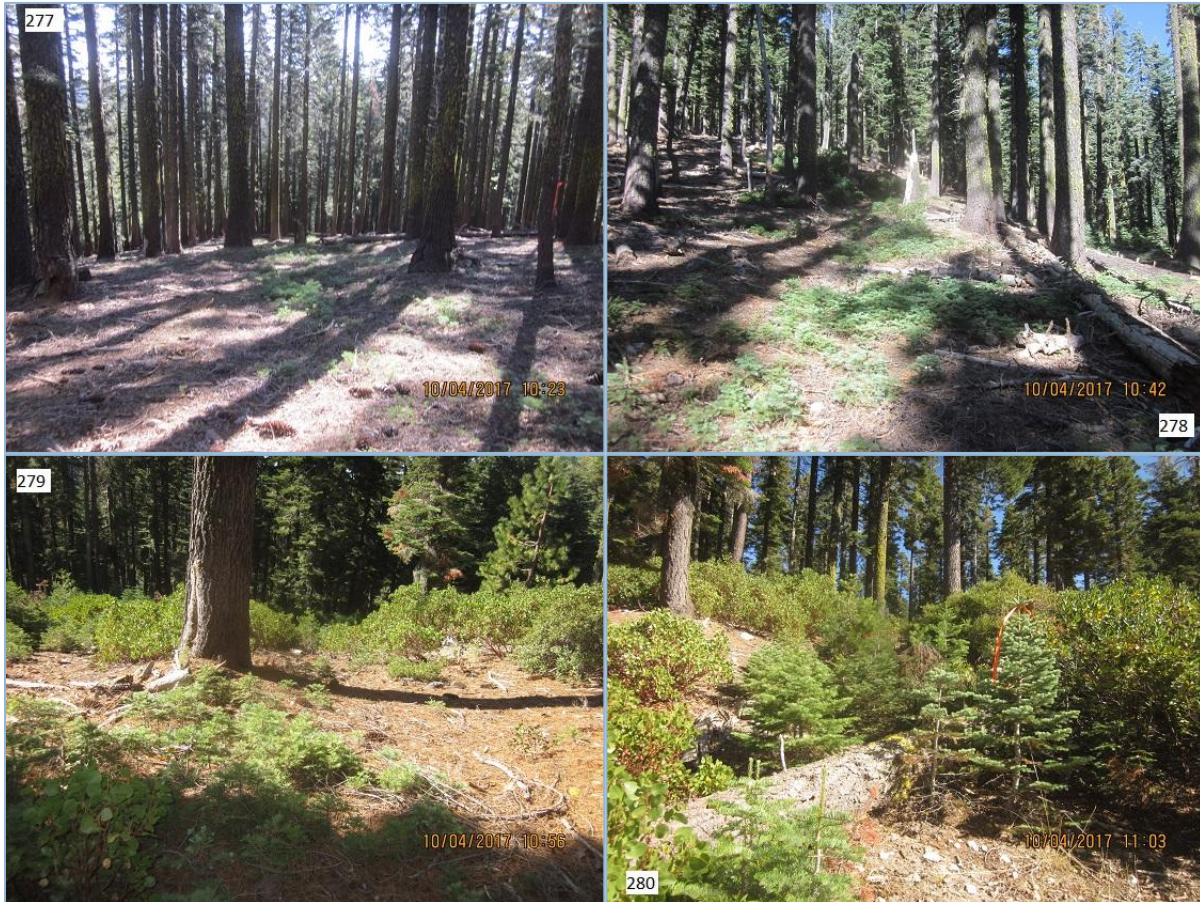
PHOTOS

Trail is no longer on ground and north end of trail is unrecognizable. Traces of an old road bed can be found, with water bars on some sections. South end of the trail has a large embankment down to road below. Area overall is thinned, but is on a steep side slope (20-25%).

Section B= Begin/ E=		Section Length	Trail Slope	Crossings	Condition Code	Cause Code	Comments	Photo Numbers
End/ P=Point								
B=204	E=205	250 ft	-25%				start of trail off road- 6M34, no trail on ground old logging road, evidence of WB's but	277
B=205	E=206		-15%				continues fall line, hard to identify	
B=206	E=207	700 ft	-20%				vegetation cover is light	
B=207	E=208	850 ft	-30%				goes fall line toward creek	278
B=208	E=209	110 ft	-5%				water bars in tact, NC to stream	
B=209			-30%				trail flattens, evidence of old bench	
							trees growing on trail bench	
							fork in trail, steep grade to road, incised	279
							overgrown, End of Trail	280

Although this trail could be re-established on its same mapped aspect, it would still be a steeper grade due to topography (estimated at 10% with multi climbing turns). Alternatively, if 6M34 (which connects to 6M34A at its north end) could be extended to the west to connect with road 23N60X (open to all vehicles), then that would provide connectivity to trails on both sides of Oro Quincy Hwy. It is recommended that the extension be for 50'> vehicles, to allow for increased access.

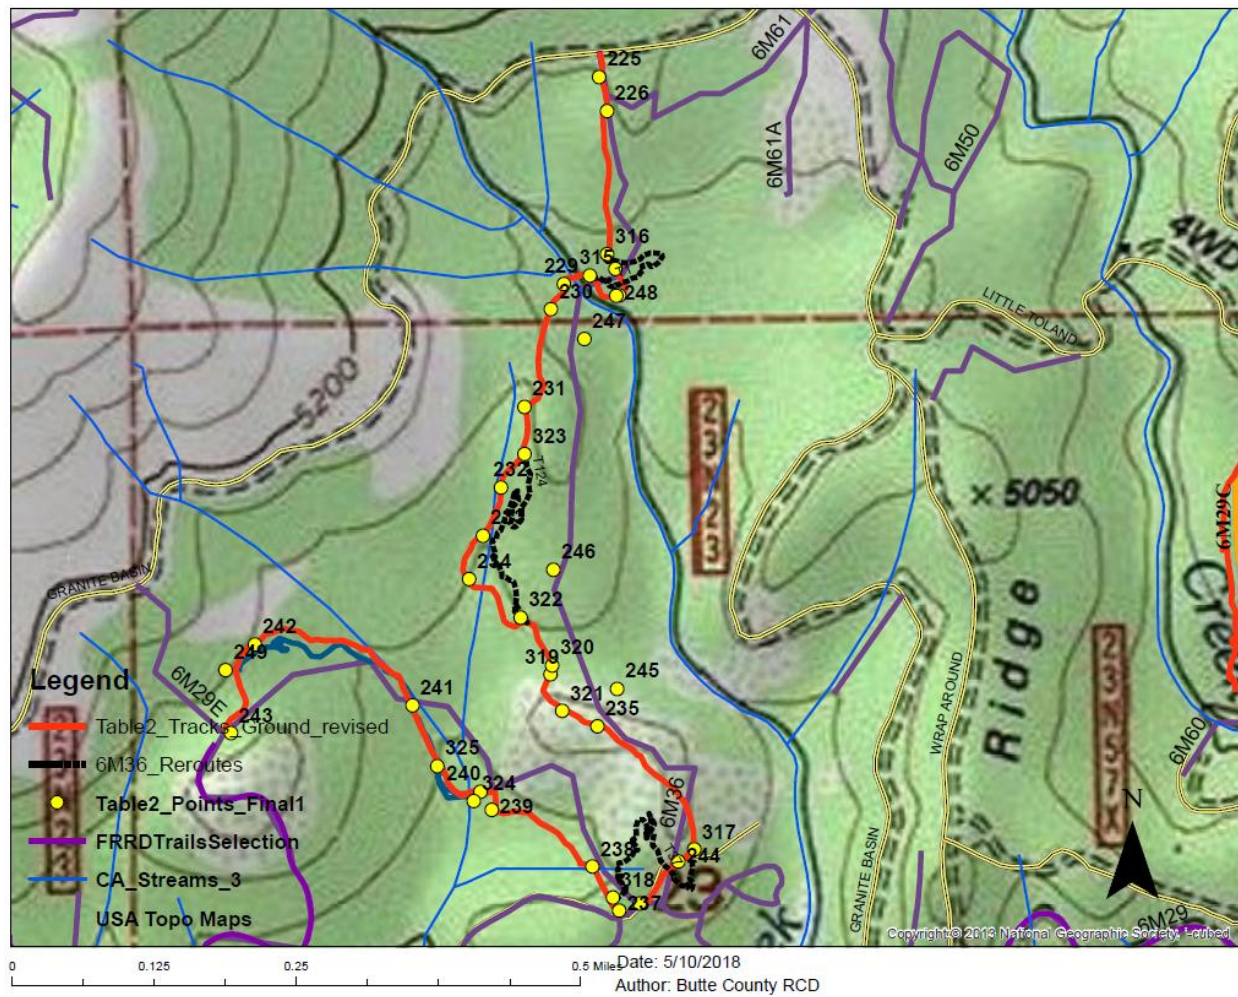
Table 2 Trails Survey -6M36

Trail to north end is in good condition, but could benefit from some drainage maintenance work. Traveling south, the trail goes into a low area and crosses a perennial stream, and is hydro connected. The south end of the trail has some soil erosion issues, and there is evidence of non-motorcycle travel on south end of trail.

Section B= Begin/ E=	End/ P=Point	Section Length	Trail Slope	Crossings	Cause Code	Comments	Photo Numbers
B 225		290 ft	-5%			Trail Start- Trail Shows Use	292
E 226						Trail 226 comes in from L	
B 226		740 ft	-10/-15%			Series of RGD functioning well/ NC	293
E 227						Basic RGD maintenance	
B 227		130 ft	-25/-30%			Steep grade, signs of surface transport	
E 228						Install 2 RGD, flattens out at bottom	
B 228		315 ft	+/- 3%			trail contours on flat area, ferns present	294
E 229						no sign of soil moisture or transport	
P 229						Perennial Stream, shows evidence of high flow	295
Site 5						not escaping channel, shows minimal bank erosion	296 LB
						steep V, naturally cobbled, stable in banks, install armored crossing	297 RB
B 229		125 ft				flat along historic flood plain, mapped trail departs ground trail	298
E 230						ephemeral side channel, forded crossing, install armoring	
B 230		530 ft	+3/+6%			trail climbs to ridge, evidence of historic ditch R, install 5 RGD	299

Recommendations: With the installation of a bridge at the perennial stream crossing, relocating the fall line sections to side hill, and moving the south end of trail to prevent non-M access, many of the current natural resource impacts would be reduced – and the recreational experience would be enhanced as well.
