Motorized Trails Assessment Study

For Table 2
Trails
in the
Plumas
National Forest

Feather River
Ranger
District

Prepared by
Butte County
Resource Conservation District

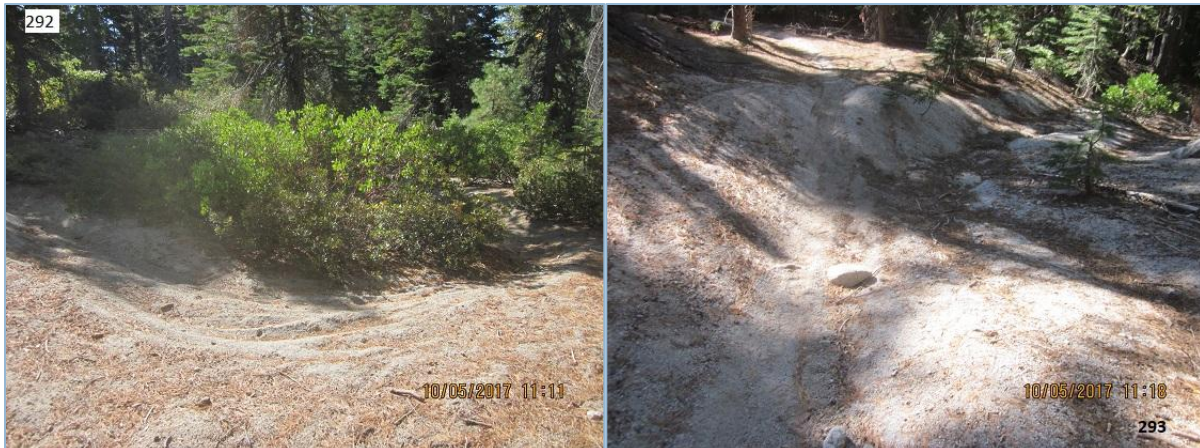
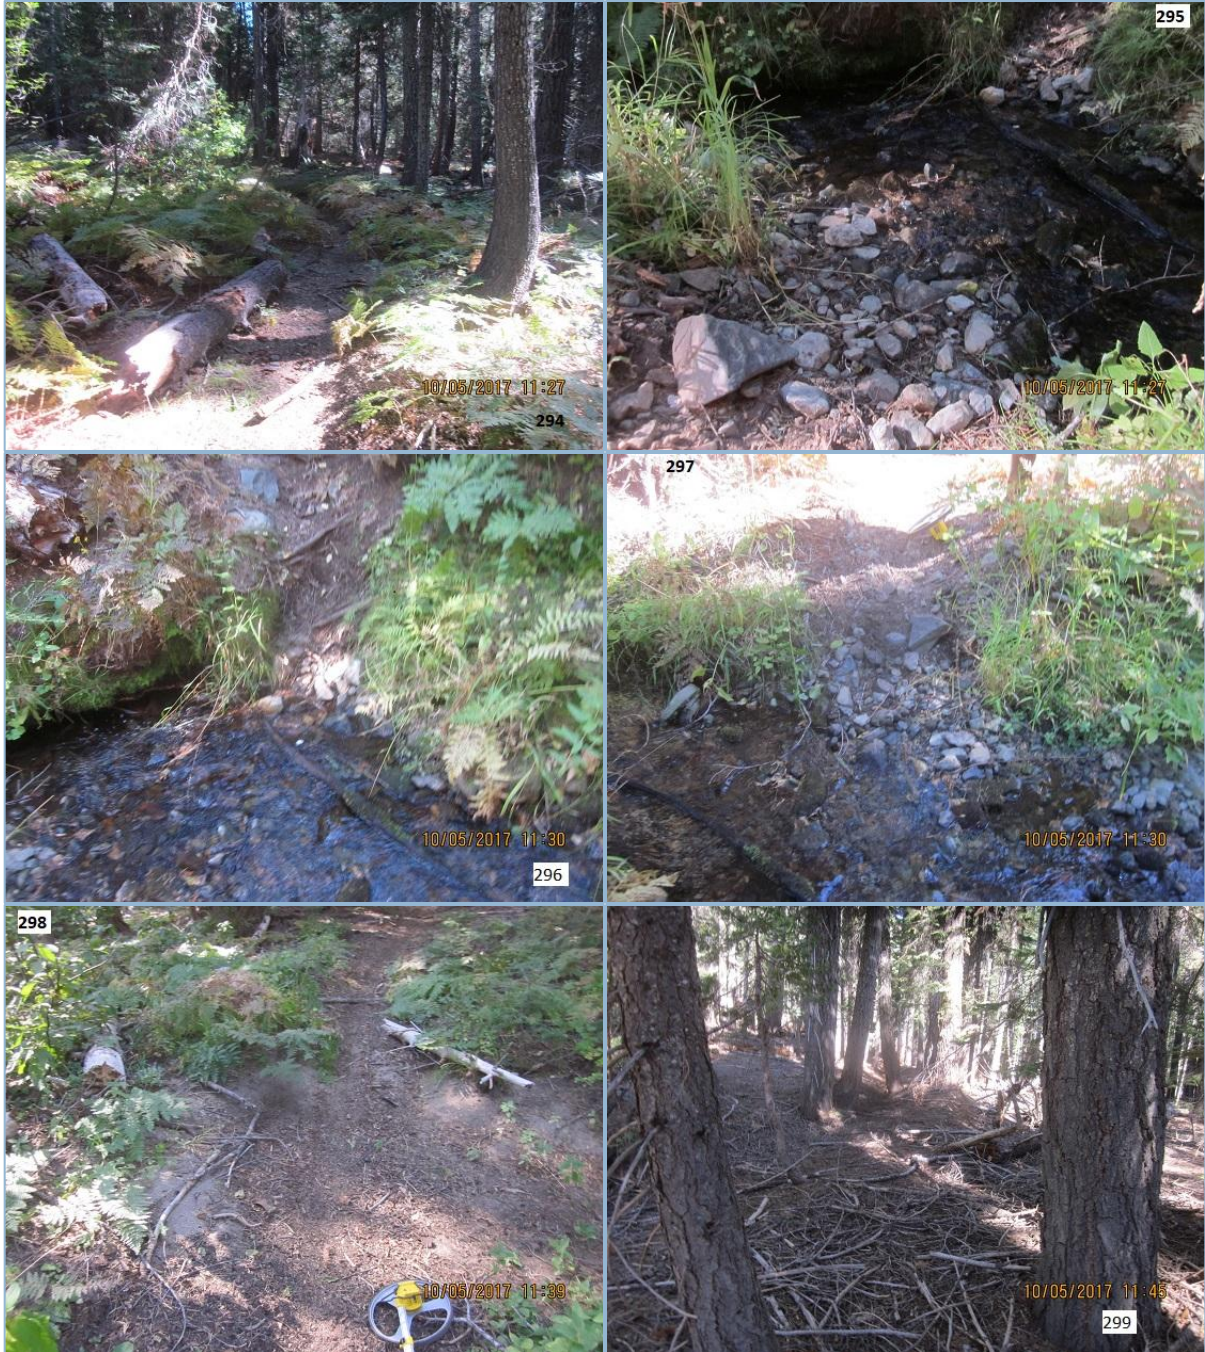
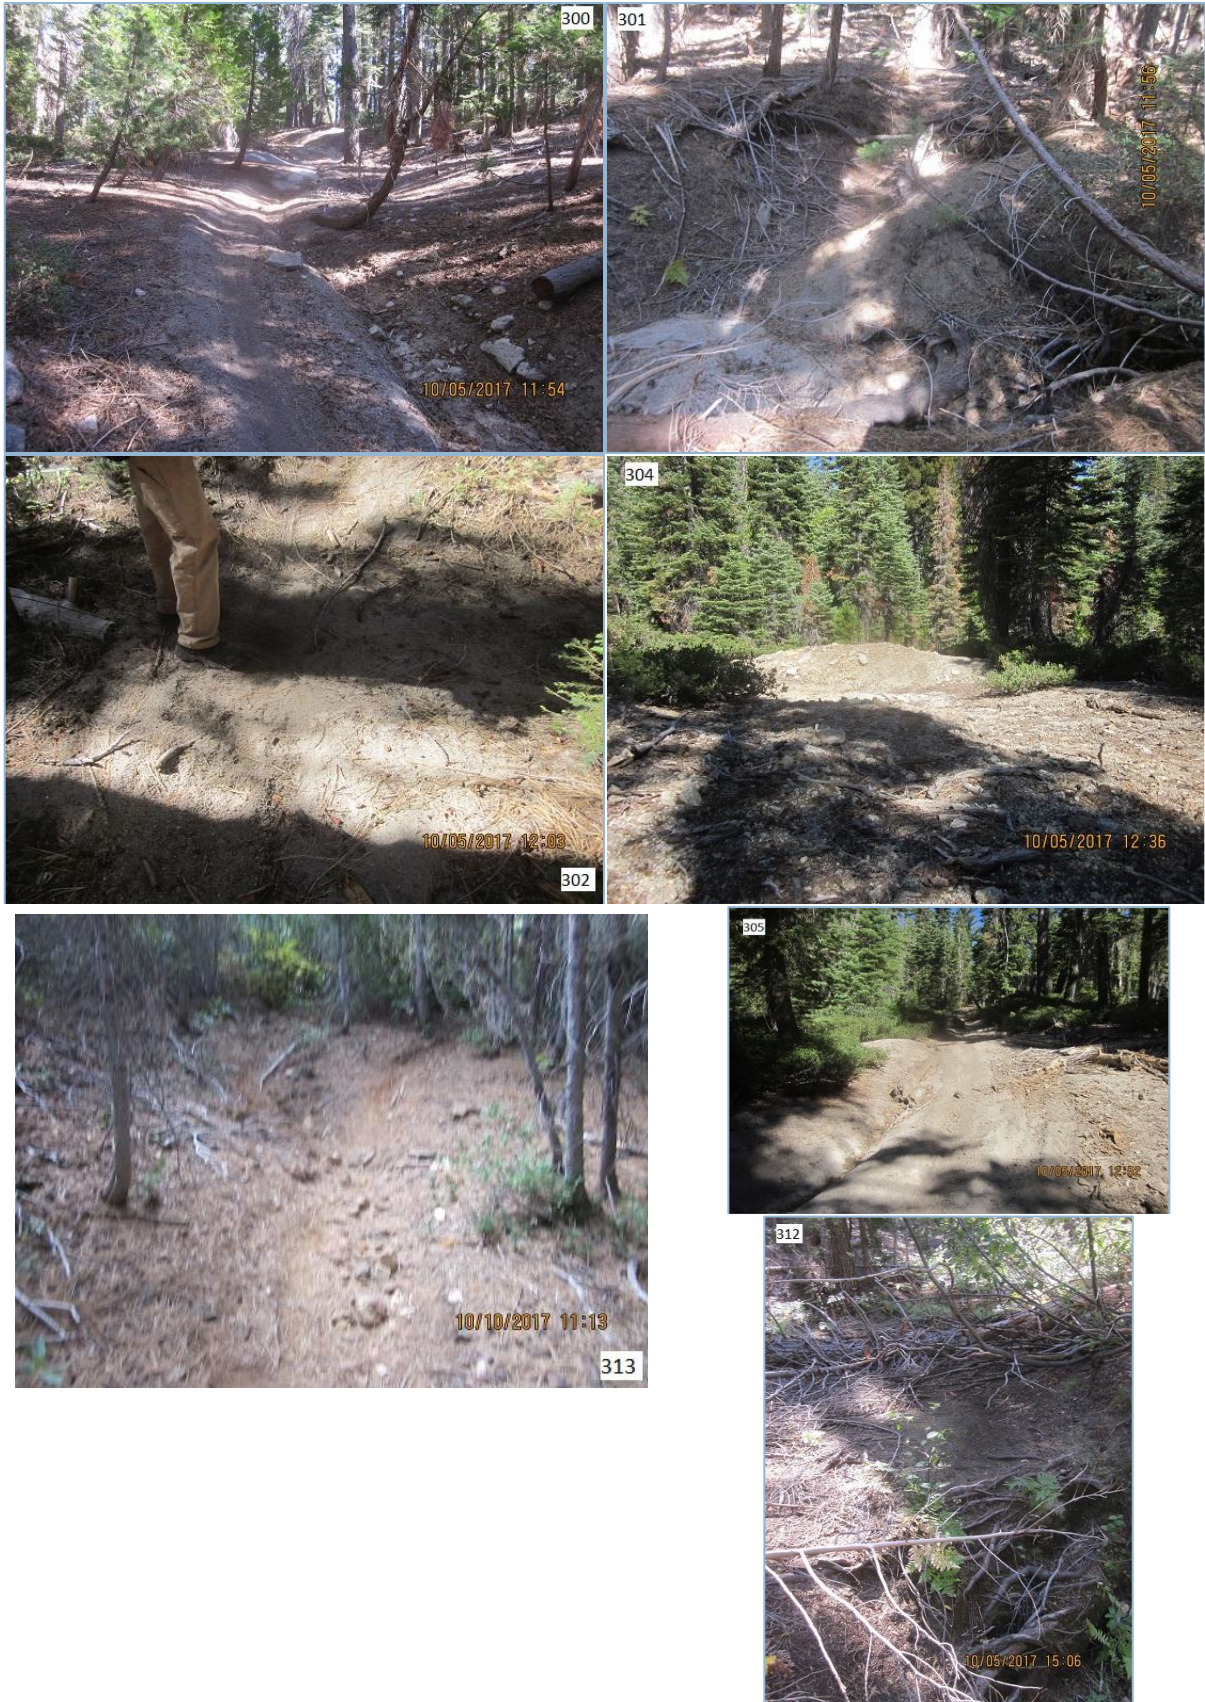
PHOTOS

Trail to north end is in good condition, but could benefit from some drainage maintenance work. Traveling south, the trail goes into a low area and crosses a perennial stream, and is hydro connected. The south end of the trail has some soil erosion issues, and there is evidence of non-motorcycle travel on south end of trail.

Section B= Begin/ E=	End/ P=Point	Section Length	Trail Slope	Crossings	Cause Code	Comments	Photo Numbers
B 225		290 ft	-5%			Trail Start- Trail Shows Use	292
E 226						Trail 226 comes in from L	
B 226		740 ft	-10/-15%			Series of RGD functioning well/ NC	293
E 227						Basic RGD maintenance	
B 227		130 ft	-25/-30%			Steep grade, signs of surface transport	
E 228						Install 2 RGD, flattens out at bottom	
B 228		315 ft	+/- 3%			trail contours on flat area, ferns present	294
E 229						no sign of soil moisture or transport	
P 229						Perennial Stream, shows evidence of high flow	295
Site 5						not escaping channel, shows minimal bank erosion	296 LB
						steep V, naturally cobbled, stable in banks, install armored crossing	297 RB
B 229		125 ft				flat along historic flood plain, mapped trail departs ground trail	298
E 230						ephemeral side channel, forded crossing, install armoring	
B 230		530 ft	+3/+6%			trail climbs to ridge, evidence of historic ditch R, install 5 RGD	299

Reroute ID	Start	End	Track	Photo
RR1	315	316	2017-10-25-123337	avoids steep grade, adds narrow single-track
RR2	322	323	2017-10-25-150629	avoids low area and erosion issues
RR3	317	318	2017-10-25-141557	moved DH
RR4	319	320	2017-10-25-143748	reroutes short section, over grade

Recommendations: With the installation of a bridge at the perennial stream crossing, relocating the fall line sections to side hill, and moving the south end of trail to prevent non-M access, many of the current natural resource impacts would be reduced – and the recreational experience would be enhanced as well.

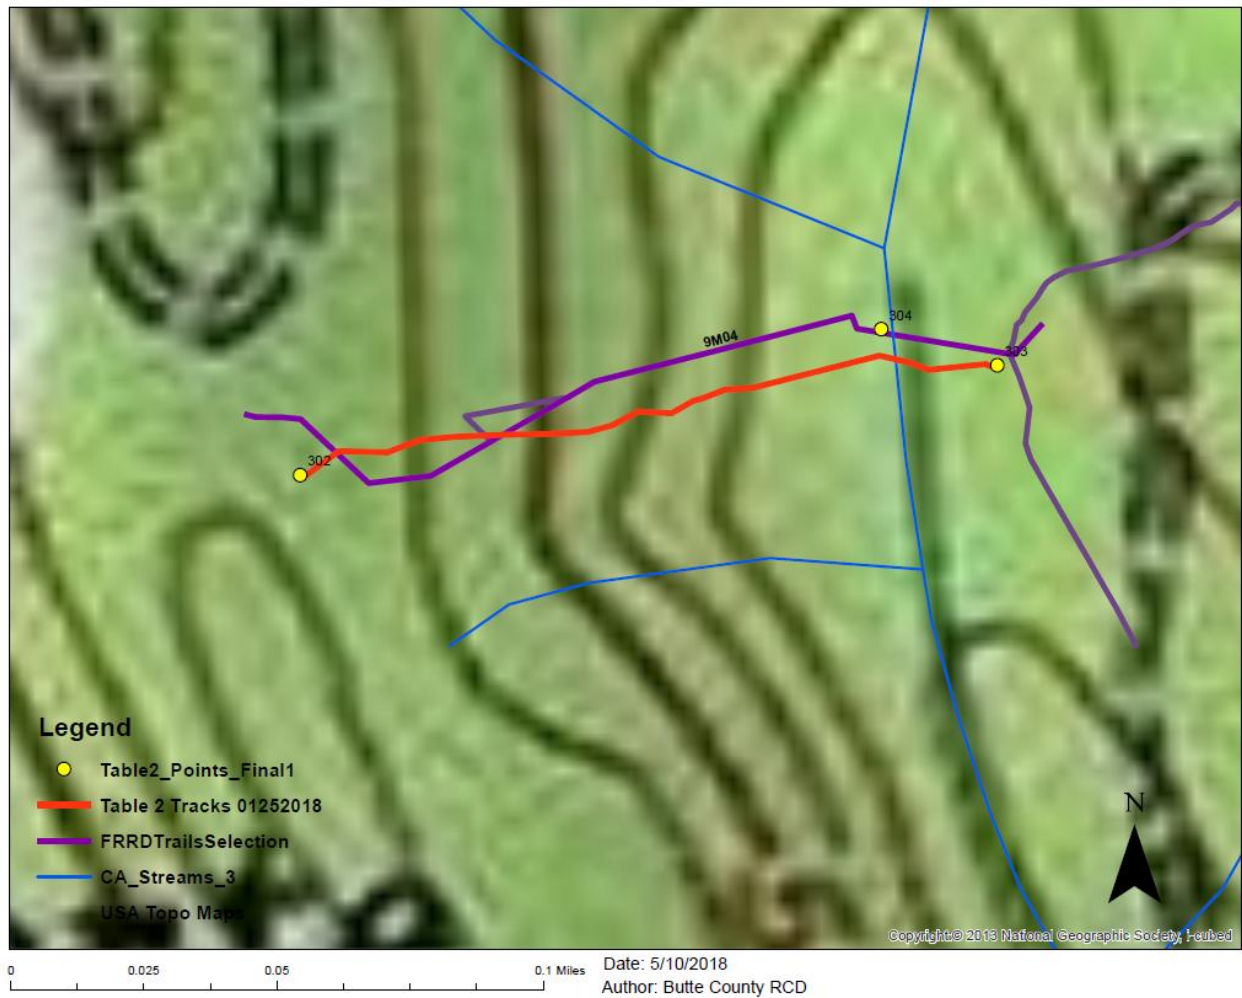
Table 2 Trails Survey -9M04

Trail 9M04
 Date 10/12/2017
 Vehicle Type M
 Trail Difficulty n/a
 Location Granite Basin
 Begin Segment 302
 End Segment 304
 Track ID 017-10-12 163722
 Trail Distance 0.18
 Avg Trails Slope
 Survey Completed by Thad, Andrew, Aric

Recommendations: Do not reestablish trail or add back to MVUM. No additional restoration work needed to decommission.

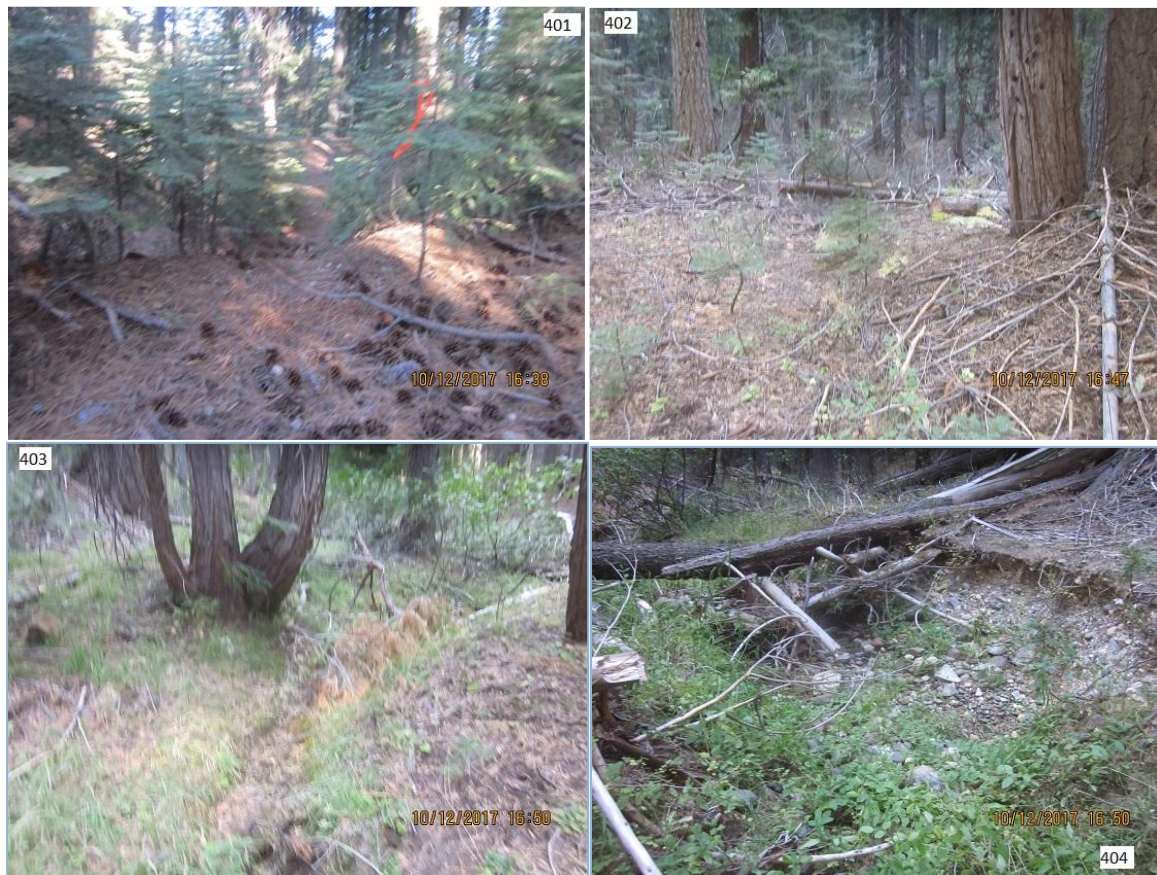
PHOTOS

Observations: From the west, the trail was hard to locate. It crosses an old irrigation ditch. Walking down slope, some evidence of old road bed and resource extraction was found. Steep fall line grade (40-50% in places) descends to perennial stream. No evidence of old trail hydro connectivity.

Section B= Begin/ E=	End/ P=Point	Section Length	Trail Slope	Crossings	Condition Code	Cause Code	Comments	Photo Numbers
B=302			0%				Trail starts off road and connects to irrigation ditch	401
E= 303			-15%				no evidence of use, no bench, entrance blocked	
B=303		43 ft					steep DH to abandoned road bench	402
		55ft						
		77 ft	-50%				fall line grade, still no evidence of trail	
		200 ft	-40%				connects to old irrigation ditch	405
		381 ft	-36%					
		524 ft	-10%				break in grade	
		601 ft	-28%					
		681 ft	-40%				continues fall line	
E=304 Site		881 ft					Perennial stream, riparian vegetation, stable in bank	403
							no sediment entering stream	404
							No evidence of trail on other side of stream

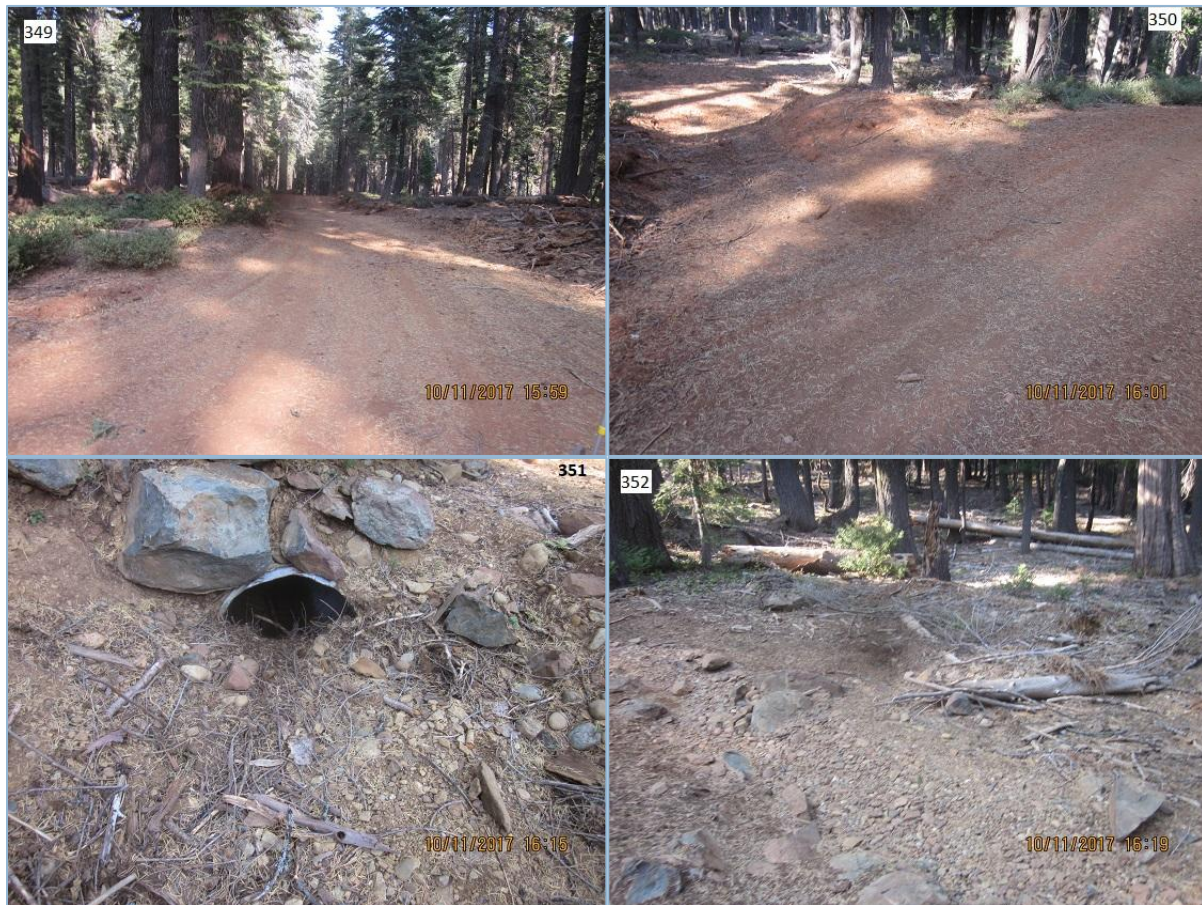
PHOTOS

Observations: On west end, trail saw recent logging operations. Logging operations had done road work on trail and had a few improperly installed culverts. Overall, trail grade is sustainable, but needs drainage work. Engineering assessment needed for perennial stream crossing (Rabbit Creek). Many of the culverts were clogged and non-functional, creating trail erosion and sediment loss. Drainage work and armoring also needs to be completed on east end of trail, where there is a riparian area and access to highway.

End/ P=Point	Section Length	Trail Slope	Crossings	Condition Code	Cause Code	Comments	Photo Numbers
B=286		-10%		Green		Trail starts at road intersection, evidence of recent logging operations/ road maintenance	349
	125 ft					15 ft width for tread, evidence of high use, no veg RGD in place and functioning	350
	337 ft					RGD in place and functioning	
	558 ft					RGD in place and functioning	
	891 ft					RGD in place and functioning	
	1121 ft					RGD in place and functioning	
	1451 ft			Yellow		culvert not installed correctly, not on grade	351
	1974 ft					culvert in place	
	2152 ft					culvert not installed correctly, not on grade	
	2410 ft					culvert, clean/ overtopping road, diverts on road	
	2561 ft					clear channel	352
E=287	2610 ft					End of timber unit- expect additional soil run off	
B=287	0 ft			Yellow		8.5 width/ rocky surface, boulder/ cobble lower side slope, water diverting down trail	352

5=289	0 ft		
	189 ft		crosses another trail
	254 ft		culvert installed- active flow
	334 ft		culvert 36' rusted
	473 ft		muddy area- import gravel 60'x10'
	660 ft		wet area- evidence of muddiness
	721 ft		culvert installed- install trash rack
	757 ft		wet area- evidence of muddiness
	1120 ft		wet area- evidence of muddiness
	1204 ft		wet area- evidence of muddiness
	1278 ft	Red	double culvert, road entrenched, flowing into stream
	1379 ft		wetland area, topping road, flow going down road
			install open bottom culvert or elevate tread
			wetland area on both sides of road
	1447 ft		wet area- evidence of muddiness
	1592 ft		box culvert installed
	1790 ft		culvert installed
	1800 ft		end of trail- consider season closure
			361

Trail is a logging road on its west end (15+ ft width) with recent drainage work associated with logging activity. This drainage work is functioning and sustainable. East of the logging work, it is recommended that road-to-trail conversion take place. This would involve pulling culverts and installing rock-armored rolling dips, to allow for natural hydro flow and reduce natural resources impacts. Sufficient quantities of rock are already on site for this work. A complete engineering assessment is needed on the Rabbit Creek crossing, due to undersized culvert and evidence of side channels. East end of road (Dutch Diggings Area) should be graded and drainage installed to reduce impact on riparian area.

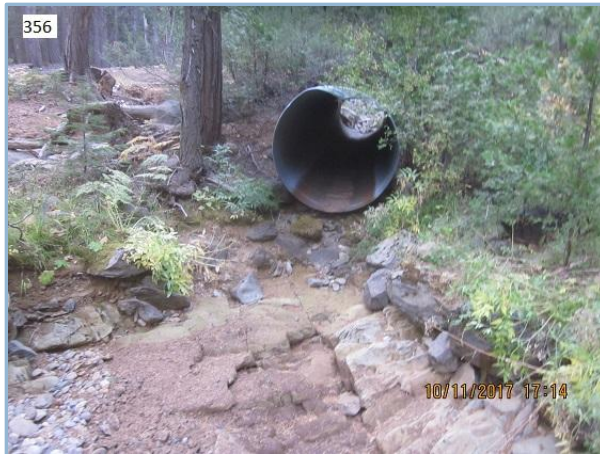
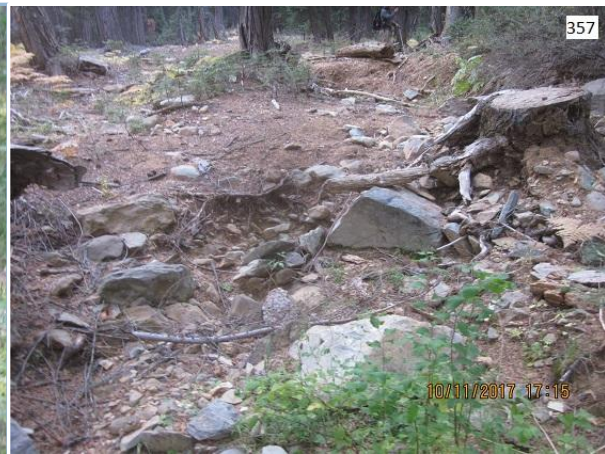
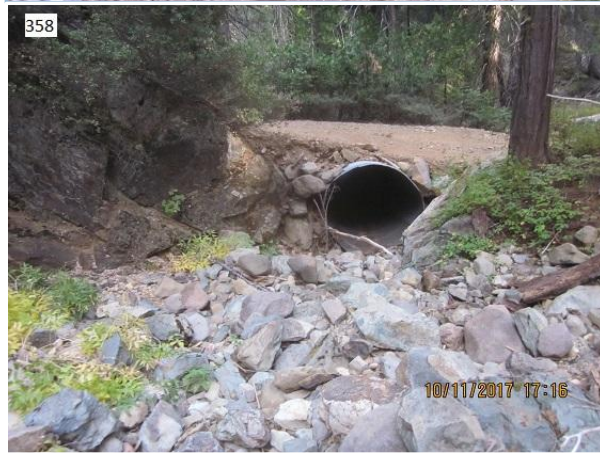
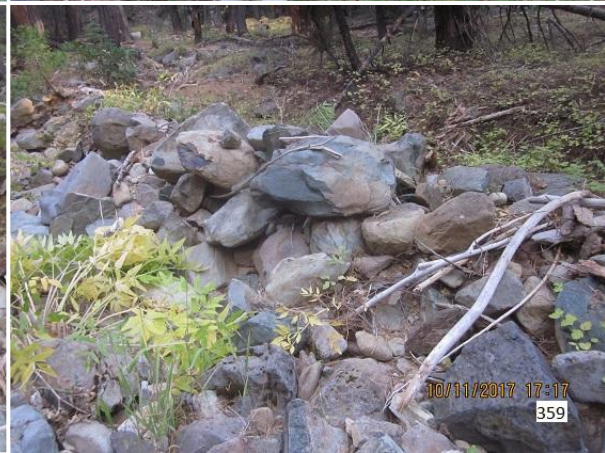
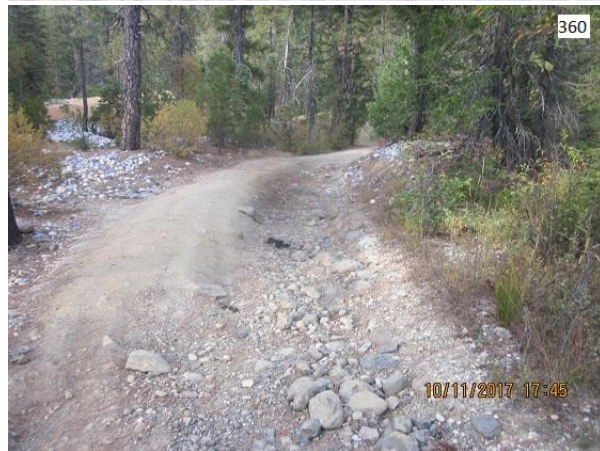
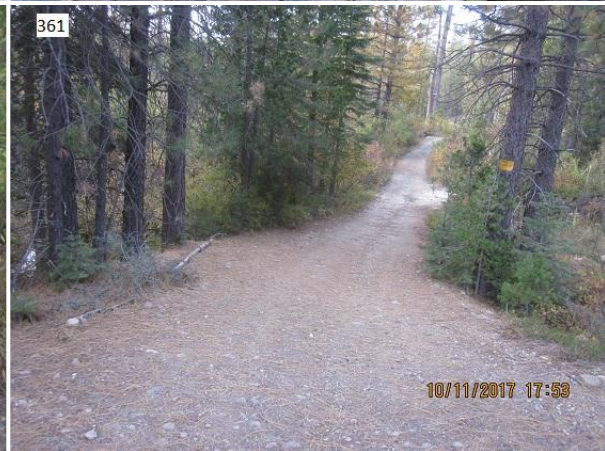
Section B= Begin/ E= End/ P=Point	Section Length	Trail Slope	Crossings	Condition Code	Cause Code	Comments	Photo Numbers
B=269	0 ft					little to no use, heavy ground cover starts across road from landing, crosses swell	326
	400 ft	5%				grassy road w/ incision 3-4"	327
E= 270	550 ft	7%				stabilized tread, no active erosion	
B=270		25%				steep/ fall line	
E=271		30%				hits landing (271)	328
B=271		0%				leaves landing	
E=272		25%				heavy vegetation- (272) lower grade/ road bed	
B=272	100 ft					3 skids come together- stays on old road bed	
E=273						trail ends	329

Recommendations: Do not add trail back to MVUM. Needs little to no work for decommission.

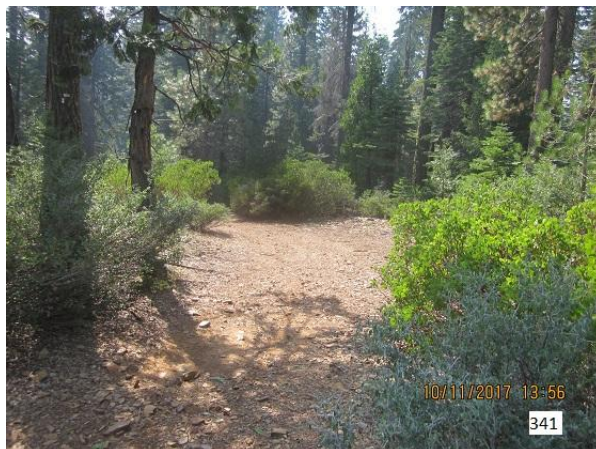
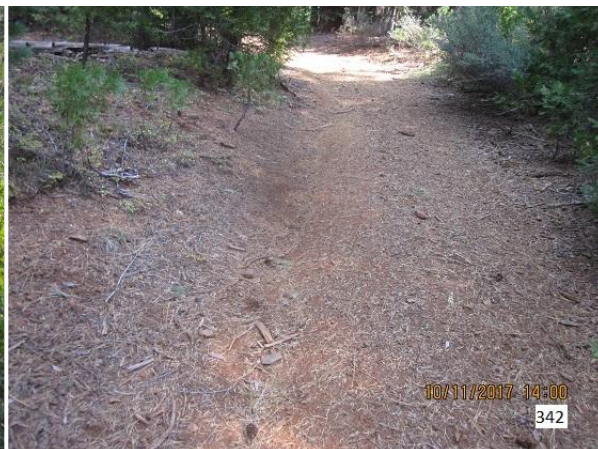
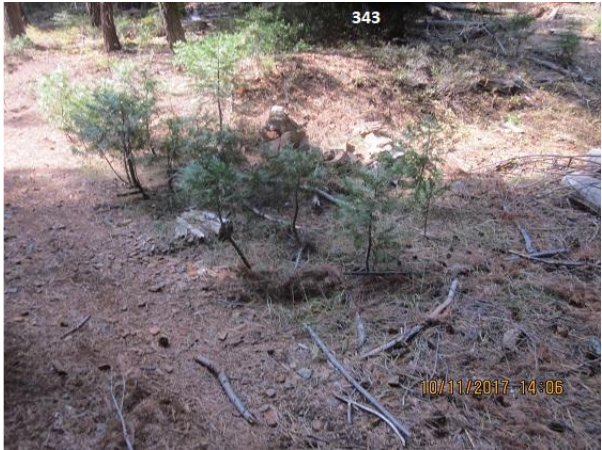
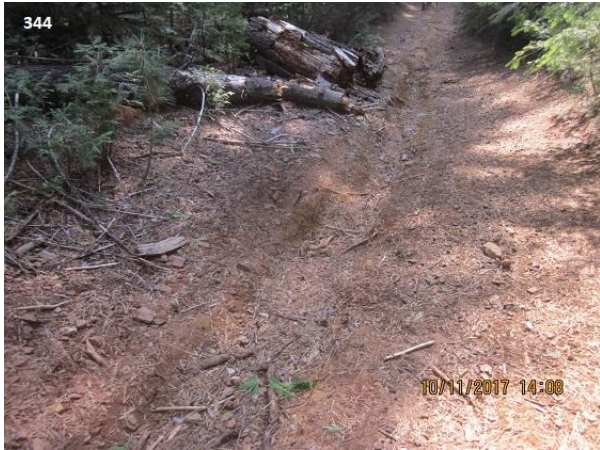
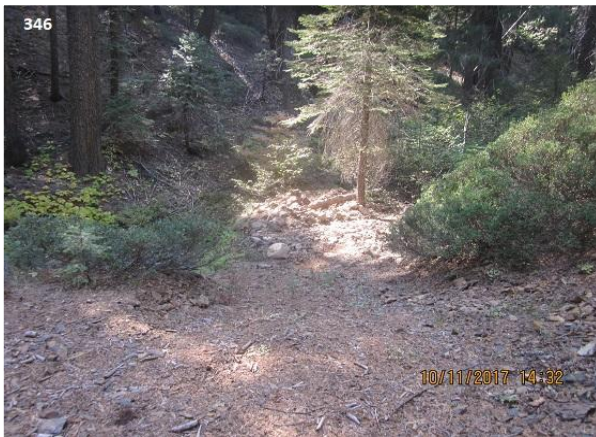
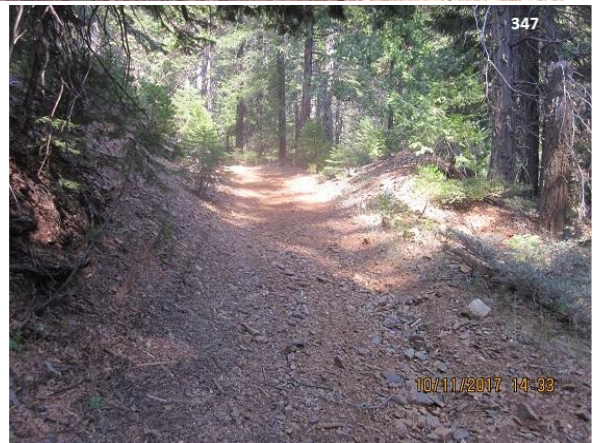
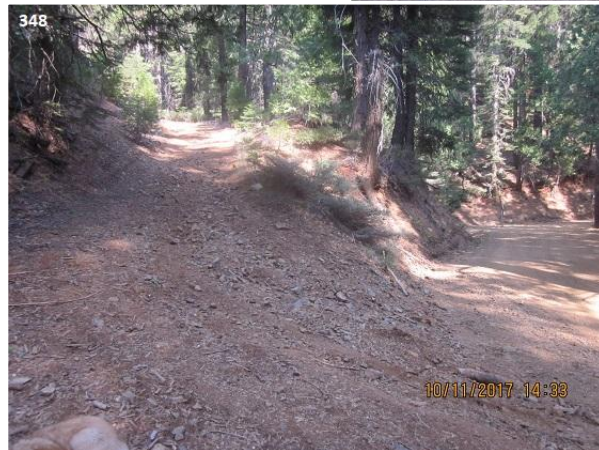
PHOTOS

Section B= Begin/ E= End/ P=Point	Section Length	Trail Slope	Crossings	Condition Code	Cause Code	Comments	Photo Numbers
B=283	80 ft	-10%		yellow		starts at intersection with road, moderate use	341
	150 ft	-12%				80 ft install RGD, berm on both sides	
	248 ft					install RGD	
	330 ft					install RGD (large) evidence of reeling	342
	450 ft	-20%		yellow		install RGD	
	543 ft					install RGD	
	672 ft					wet crossing, stable, removes berms	
	710 ft					install critical dip just below crossing	343
	830 ft					install RGD	344
	895 ft	5%				swell crossing, stable	
E=284	950 ft	-6%				intersects road	
S=284	0 ft						
	20 ft					install RGD, water running down road	
	102 ft	0%				goes flat	
	205 ft	-12%				install RGD- water on trail	
	303 ft					install RGD	
	433 ft	-3%				install RGD- trail goes flat	
	600 ft					install RGD	
	690 ft	-15%				install RGD	
	840 ft					install RGD	
	920 ft					install RGD	
	1020 ft					install RGD

1100 ft					install RGD	
	1195 ft	-20%				install RGD- grade increases	
	1240 ft	-25%				install RGD- grade increases	
	1300 ft						
	1340 ft						
	1390 ft					install RGD- inboard ditch start	
	1490 ft					inboard ditch end	
E=285	1510 ft					End of trail- installed armored drainage on R runoff from trail going into perennial stream	346/347
						rock available on site	348

Recommendations: Complete MYLF study for crossing and complete required mitigations. Complete prescribed drainage work, then add back to MVUM.

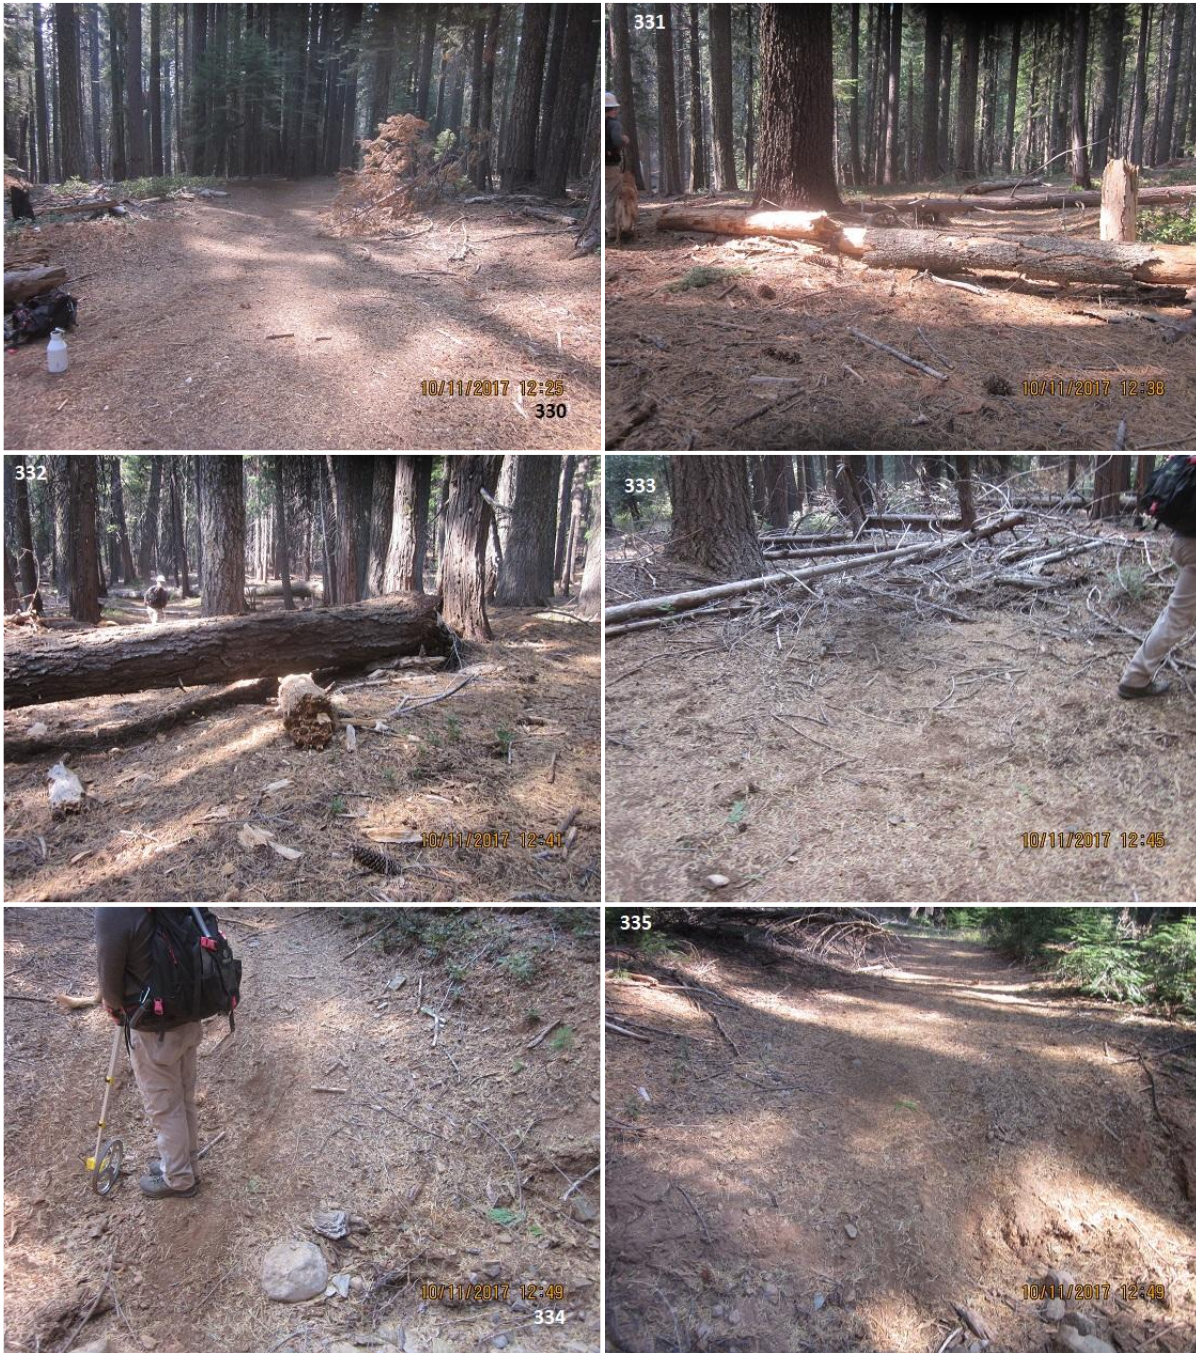
PHOTOS

Current Trail Usage: Moderate usage. Access has been limited by fallen trees. Crossing needs recommendation for mitigation (armored or bridge). Rest of trail needs drainage work (rolling grade dips) and trees removed.

Section B= Begin/ E=							Photo Numbers
End/ P=Point	Section Length	Trail Slope	Crossings	Condition Code	Cause Code	Comments	
B=274				Yellow		trail starts and road intersection, 12-15" w not capturing run-off from road low/ mod use, litter coverage RGD need maintenance/ additional	330
	175 ft					install RGD- keep water off road	
	326 ft	10%				road forks at campsite	331
	400 ft					RGD need maintenance	
	540 ft					RGD need maintenance	
	590 ft					trees in trail grade levels	
E=275	0 ft						
S=275	280 ft					large tree forcing reroute	332
E=276	350 ft			Yellow		ephemeral drainage- NC debris dam create sediment detention basin	333
B=276	0 ft						
E=277	150 ft					excavate/ tree at 30 ft	
277 Site				Red		intermittent stream crossing incision 3-4', rock substrate, vertical bank	RB 334 LB 335
						some erosion, appears stable, vegetation Reroute created on L side crosses downstream	
						depositional zone-step down w/debris dam lay back R slope/ armor, install critical dip

B=277	0 ft	15%		Yellow			
	95 ft					install RGD	
	150 ft					install RGD	
	200 ft	20%				grade increases	336
	300 ft					RGD maintenance -failing	
E=278	390 ft					break in grade	
B=278	0 ft	-5%					
	80 ft					install RGD	
	125 ft					install RGD	
	212 ft					install RGD	
	308 ft					2 large trees 2'd and 3'd	337
	367 ft					reroute goes uphill	
	497 ft					install RGD after swell	
	572 ft					reroute goes below down tree	
	751 ft					2 large trees 4'd	338
	775 ft					reroute rejoins trail	
	806 ft					reroute 3 large trees	
	883 ft					large tree in trail	
Site 279						ephemeral crossing from irrigation ditch	339
	909 ft	10%				reroute rejoins trail	
	1039 ft	15%				grade increases though switchback, install RGD	
	1275 ft					install RGD	
	1365 ft					reroute due to tree	
E=280	1425 ft					reroute rejoins trail, break in grade	
S=280	0 ft	1%					
	100 ft	3%				install RGD	
	153 ft					tree across trail	
	420 ft					install RGD

480 ft					install RGD	
	575 ft					install RGD	
	644 ft					install RGD	
	840 ft					install RGD	
E=281	912 ft					2 trees in trail, break in grade	
S=281	0 ft	-15%					
	51 ft					install RGD	
	110 ft					no water bar	
	221 ft					install RGD	
	360 ft					install RGD	
	475 ft					install RGD	
	585 ft					knick to drain low area	
	750 ft					install RGD	
E=282	935 ft					hits road intersection, end of trail	340

Recommendations: Consult with a specialist about the intermittent crossing (either bridge or armored crossing). Then, complete the drainage mitigations, remove the downed trees, and finally add back to MVUM.

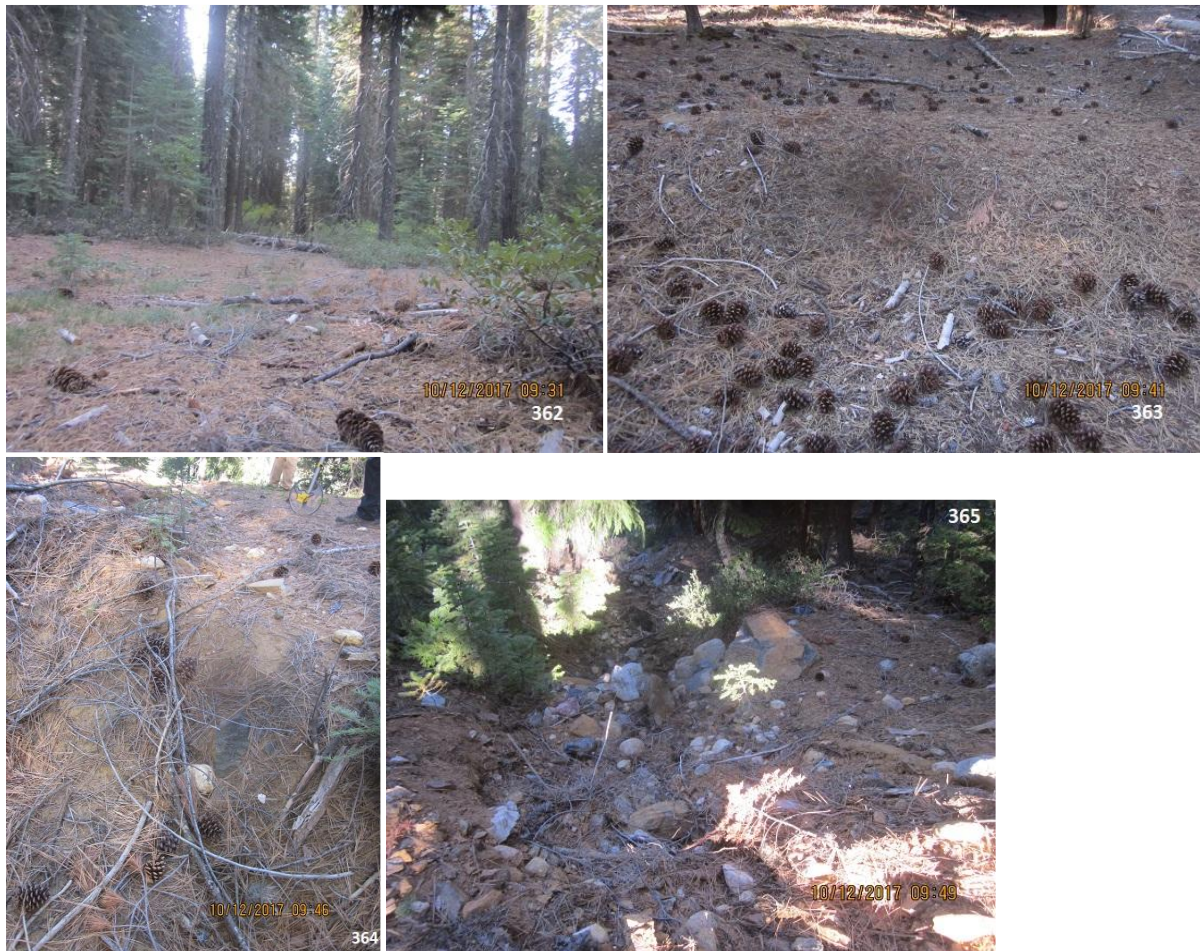
PHOTOS

Natural Resource Impacts and Sustainability: There is a multi-culvert crossing from mining area and evidence of water topping trail; this area needs additional hydro and engineering evaluation for impacts and failure possibility (consider decommission of section).

Section B= Begin/ E= End/ P=Point	Section Length	Trail Slope	Crossings	Condition Code	Cause Code	Comments	Photo Numbers
B=292	80 ft	-5%		yellow		start of trail, 20-25' w avg, trees down at start little/ no use, stable tread, leaf litter	362
	401 ft					WB- maintenance	
	543 ft	-10%				WB- maintenance, increase in grade	
	750 ft					WB- maintenance	363
	926 ft					tree/ culvert	
	1075 ft						
	1170 ft						
E=293						culvert buried, surface erosion 2-3"Dx4' W outlet from mining area, topping road	364
S=293		3%				change in slope	365
	640 ft	-5%					
	950 ft						
E=294	1155 ft			Red		mining site, confluence, 3 culverts, intermittent	366
						culvert US blocked	367
						culvert DS	368
						2 channels, topping road	
						Pull culverts/ open channel, excavate material	
						rehab area, culverts incorrectly positioned	
						not natural stream flow	
S=294	0 ft	15%		Yellow			
	1250 ft					WB-maintenance needed, surface reeling	370

1403 ft					install RGD	
	1540 ft					install RGD	
	1680 ft					install RGD	
	1900 ft	0%				flat, old landing	
	2419 ft					install 3 sediment basins, road is low	
E=295	2655 ft					end of trail, large tree across trail	371

Complete additional evaluation of crossing for recommendation and cultural SPMs. Due to lack of trail use and lack of connectivity, this trail has a low priority for adding back to MVUM. May have value to access historical area of St. Louis.

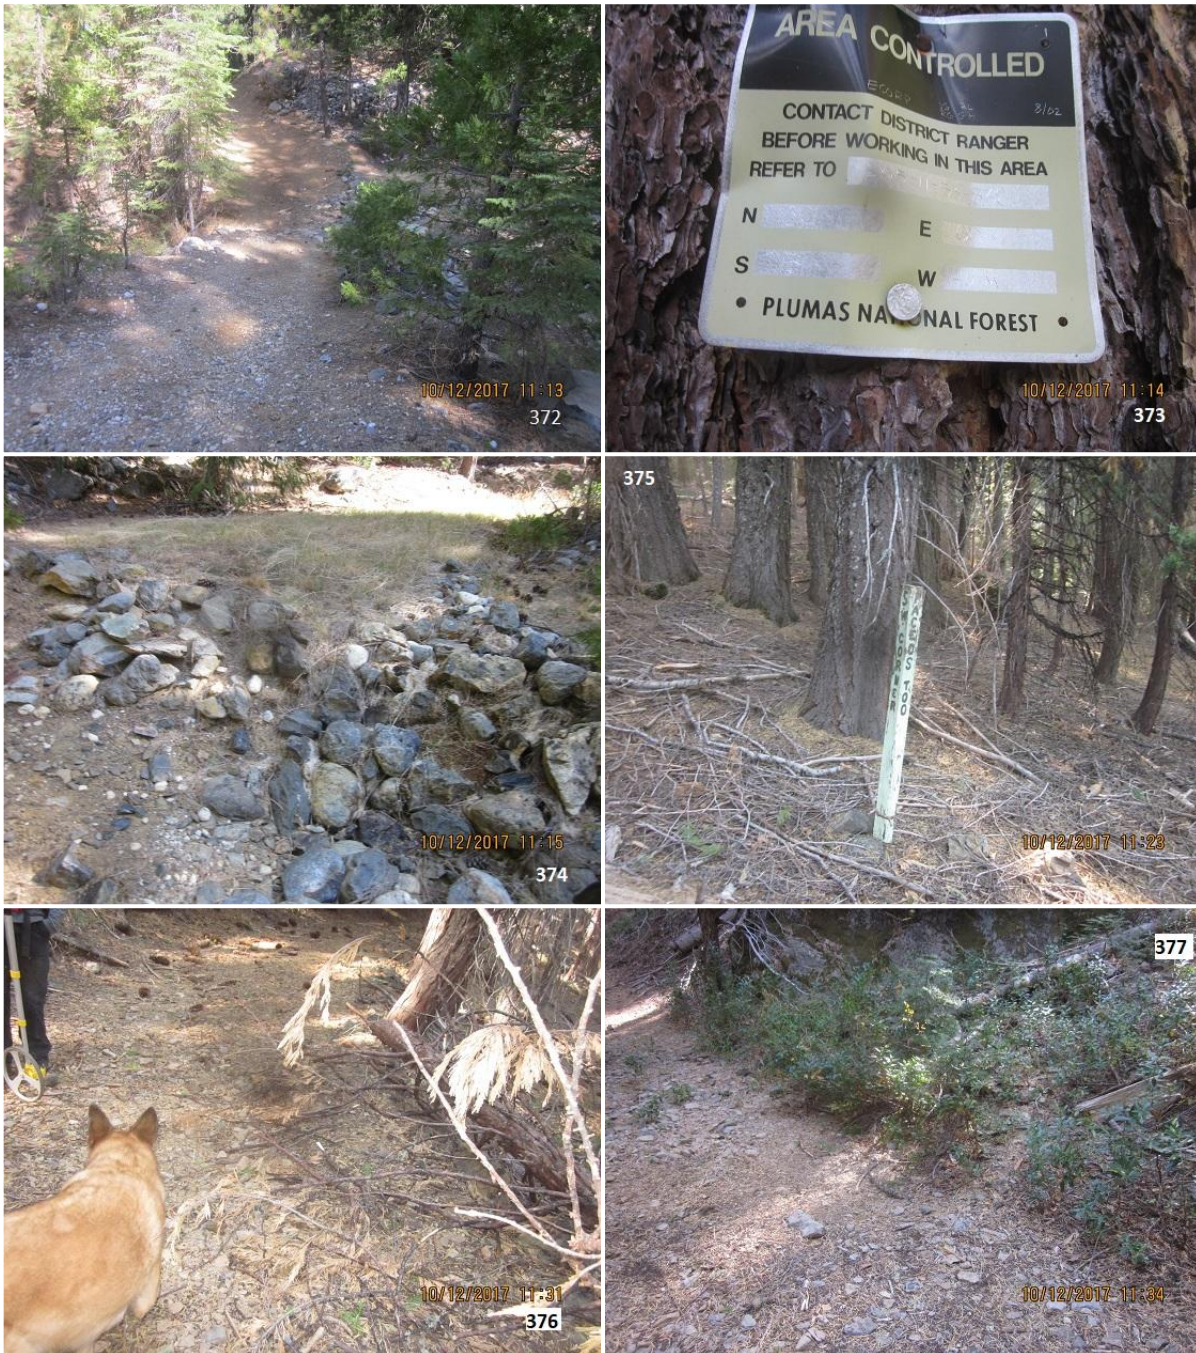
PHOTOS

2705 ft						swell, stable, remove berm, outslope	
	2833 ft		10%				swell, stable, old pipe	
	2963 ft						install RGD	
	3152 ft		-5%				break in grade	
	3290 ft						install RGD	
	3380 ft						install RGD	
E=298	3500 ft						trail ends	390
